Haiti RAPID Projects: Structures

Effects of the January 2010 Haitian Earthquake on Selected Mechanical and Electrical Equipment

Evaluation of Analytical Assessment Tools based on Observed Performance

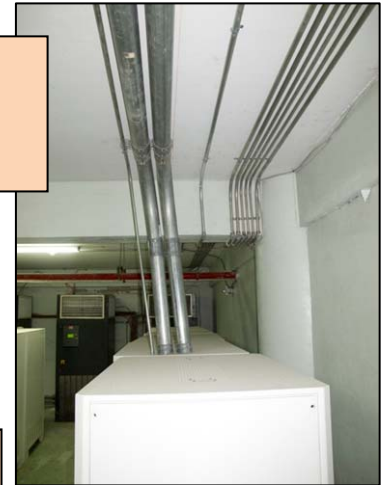
Unanchored
UPS system
(Digicel)

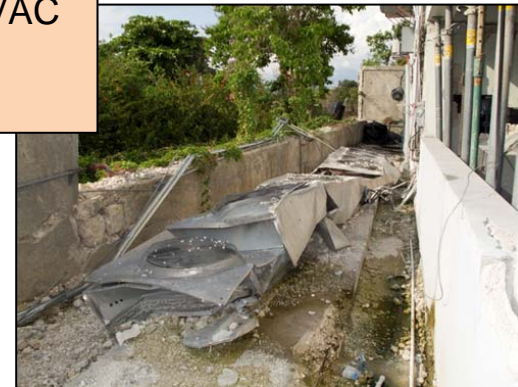
Crushed
outdoor HVAC
condenser
(Digicel)

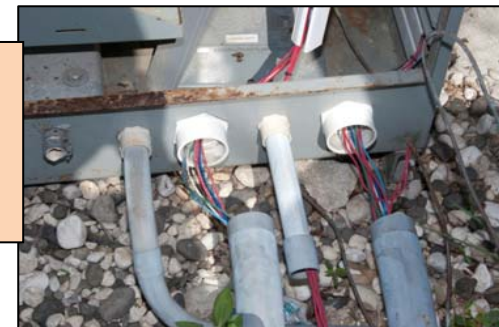
Conduit
separation
(General
Hospital)

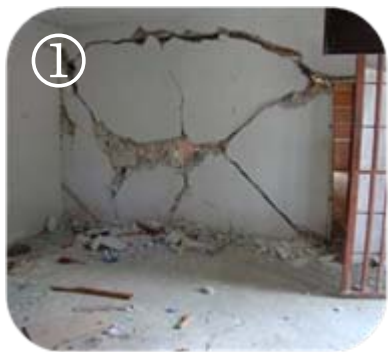
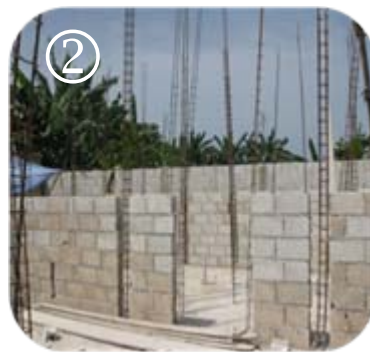
- Cement Masonry Unit (CMU) as partitioning element ①
Sufficiently stiff to attract forces, insufficient strength to resist them → wall fails in shear, immediately transfers forces and fails neighboring columns
- Undersized, inadequately detailed columns ②
Generally results from using CMU as formwork
Economic constraints lead to widely spaced transverse reinforcement → lack of confinement
- Lateral systems not adequately tied together
Larger “mansions” employed same flat slab/column systems used in smaller homes, with slabs inadequate to engage undersized columns over plan and with insufficient reinforcement to facilitate transfer of shear from slab to columns
- Excessive mass
Heavy partitioning CMU walls, provision for adding floors later leads to use of heavy slab roofs
- Poor materials, construction practices, construction in stages with variable material quality and workmanship

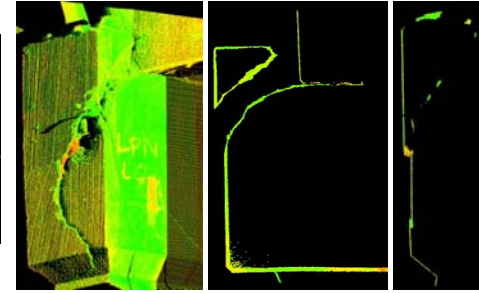
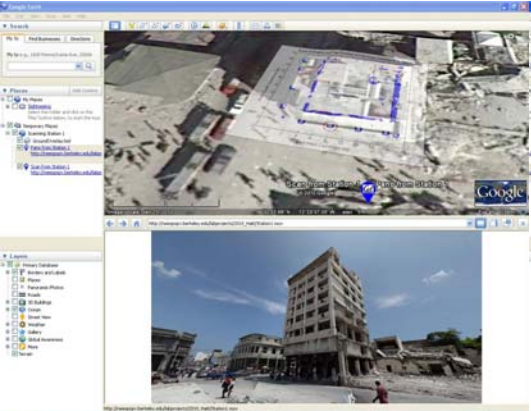
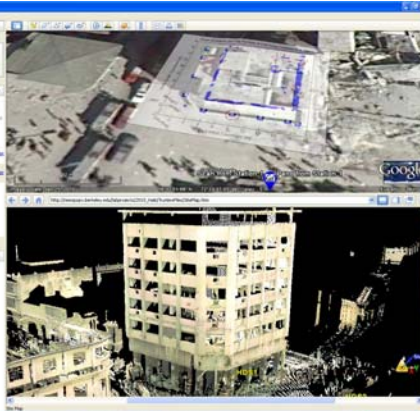
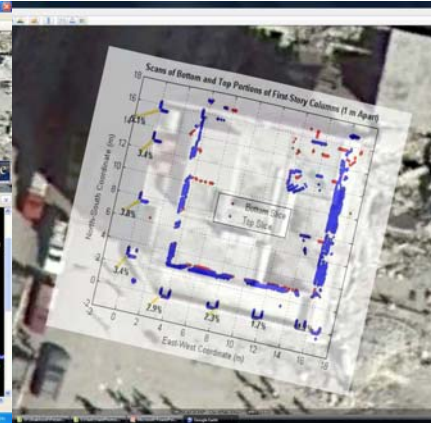
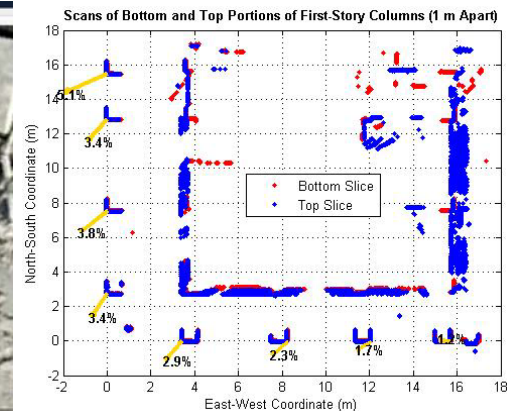
A damaged bridge scanned from 2 positions & Shear key sections @ face & mid-plane

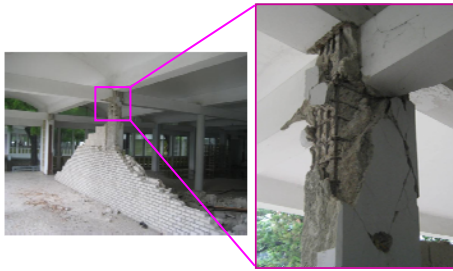
Damage mapping

column shear failure

pounding damage

wall pier failure

masonry wall failure

column shear cracking
