**Technical Council on Lifeline Earthquake Engineering (TCLEE)  
Preliminary Report  
27 February 2010 M<sub>w</sub>8.8 Offshore Maule, Chile Earthquake**

**Introduction**

The TCLEE Maule Chile earthquake team conducted a post earthquake investigation of the lifelines performance in the impacted region from 10 – 17 April. This report provides a summary of:

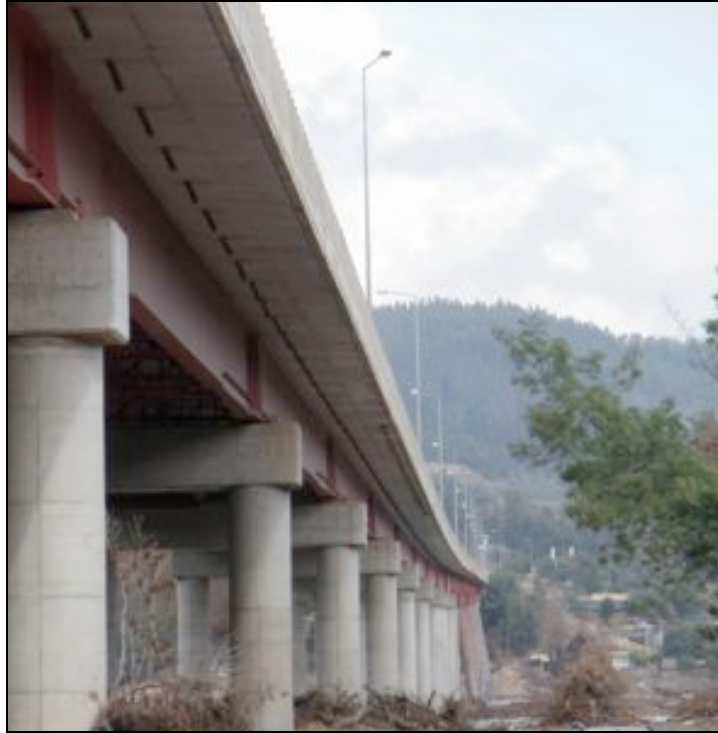
*Tsunami damage to bridge in Constitución. The bridge girder was lifted by the tsunami and moved inland about 1 ft for a distance of about 6 bents. During the TCLEE team visit on April 16, 2010, the bridge traffic was being controlled to one lane of traffic. Team members witnessed official search activities for missing persons.*

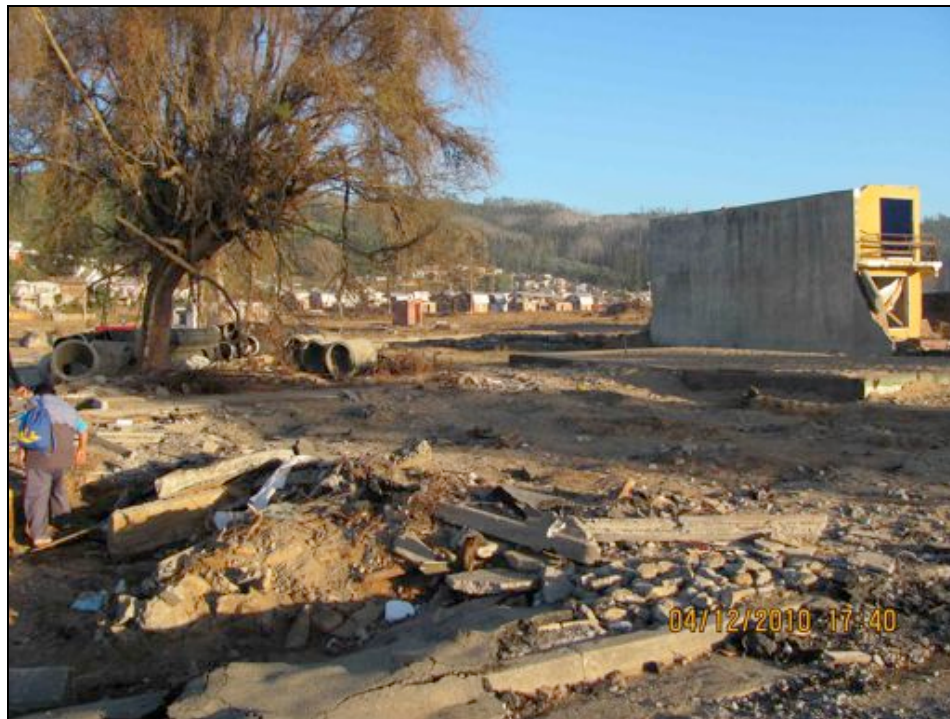
*Dichato Tsunami damage*

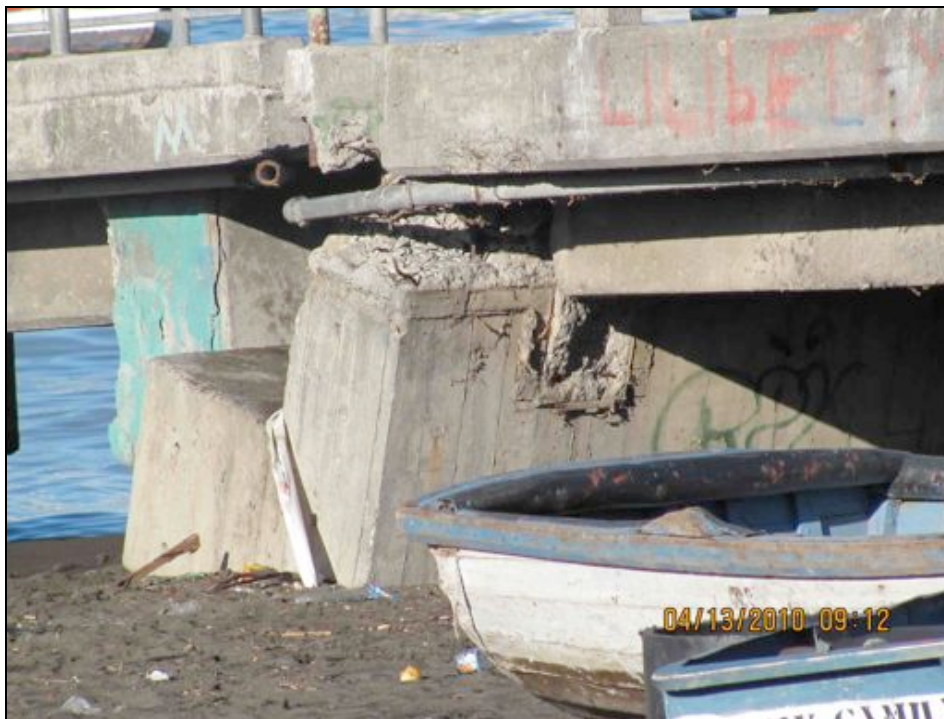
*Liquefaction and lateral spreading damage at Coronel fishing port. Note the damaged lifeline.*

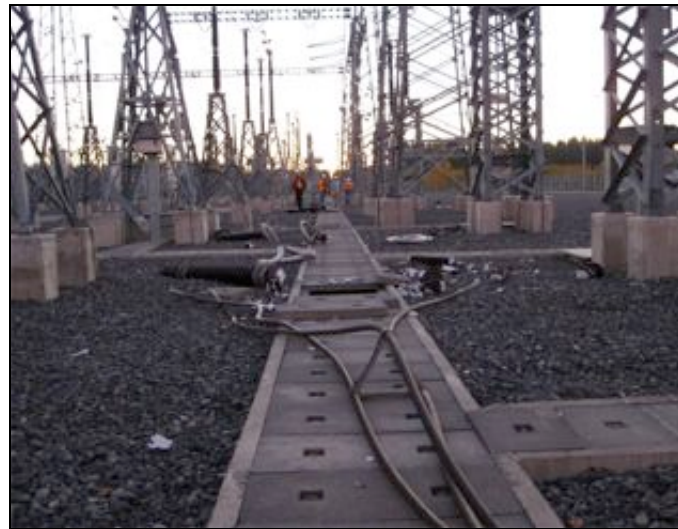
*Damaged candlestick style live-tank circuit breakers*

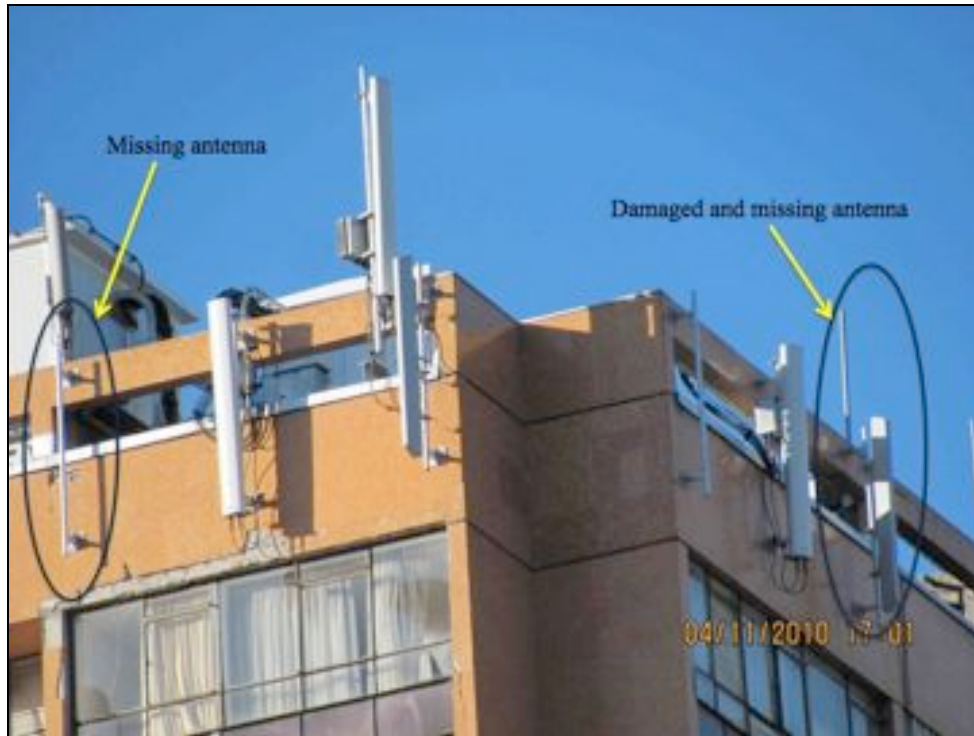
*Fallen cell site antenna*

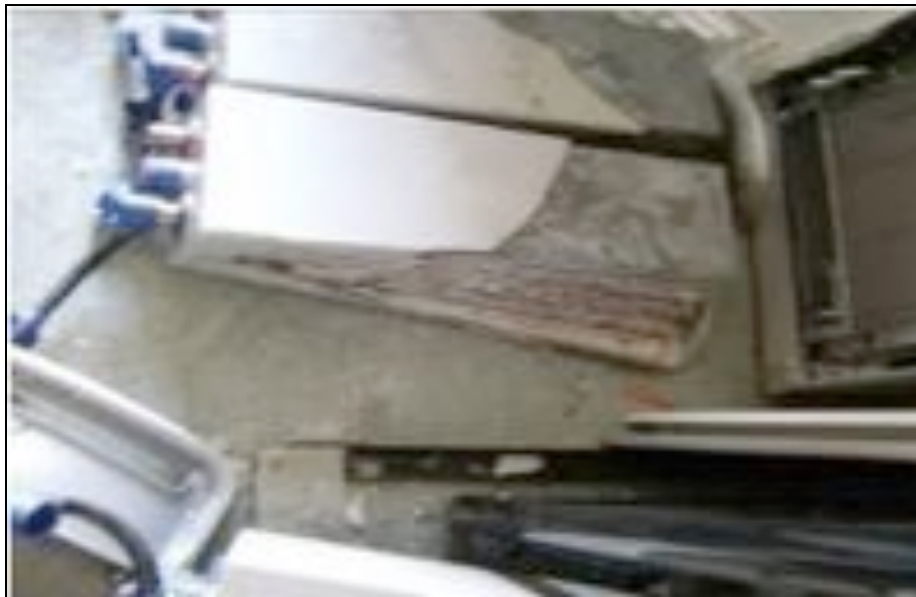
generators to power all the sites. About 50% of the cell sites had battery failures because of damage to batteries. Failures during shaking were due to the fact that most of the battery racks were not anchored and batteries were not secured on the shelves of the battery racks. Fallen antenna from towers were another common occurrence in Regions VII and VIII. A number of cell sites installed on roofs of commercial buildings were damaged when the buildings were structurally damaged. Cell site towers are designed based on wind load. Based on our collected information, one operator had issues with antennas in 50 % of their sites. At least two towers collapsed, one was a monopole design on poor soil while the other was mounted on a concrete water tank that collapsed.

*Unsecured batteries on unanchored battery rack fell off the rack and damaged (Courtesy Carlos Urzua Acuña)*

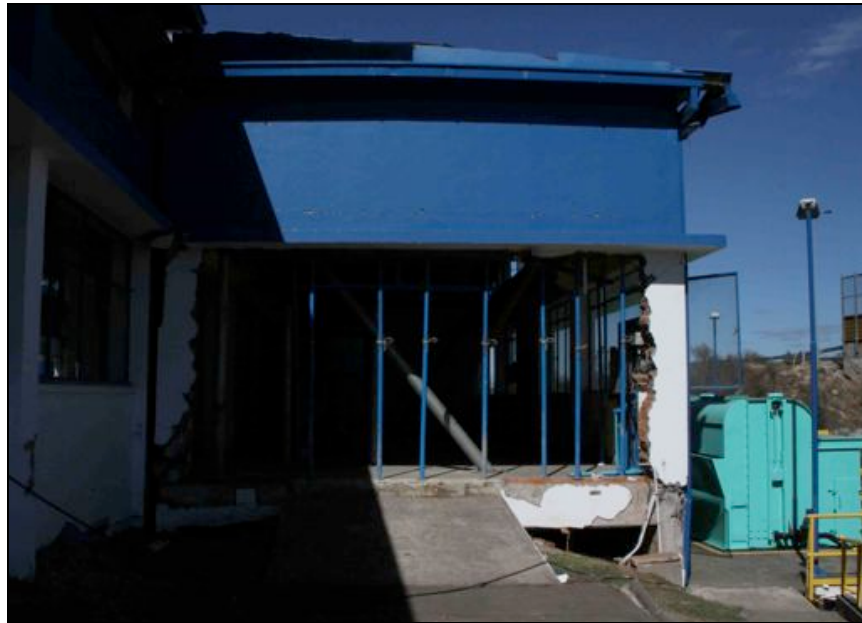
*Collapsed wall at Concepcion Water Treatment Plant Raw Water Pump Station*

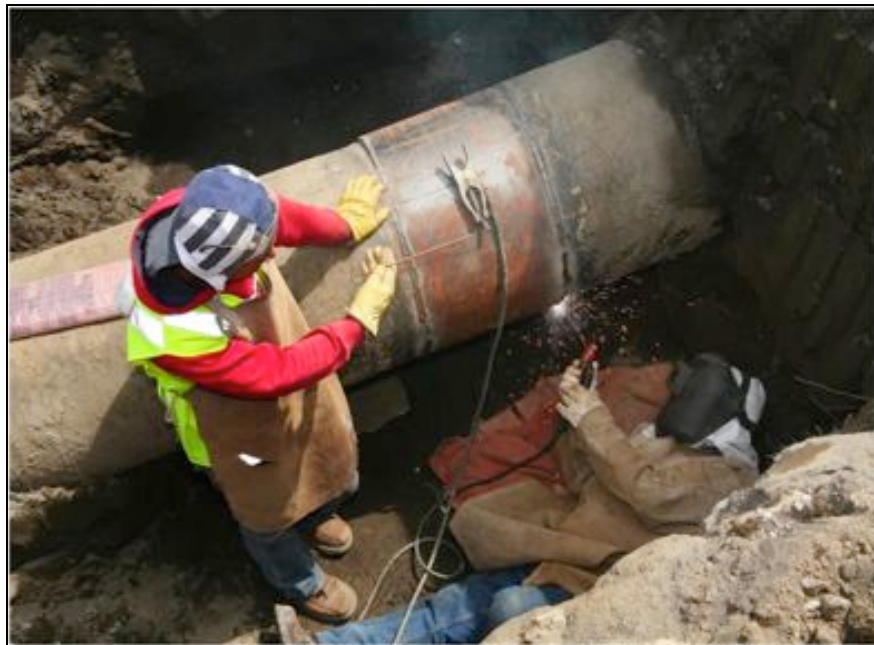
*Damaged Large Diameter Welded Steel Water Pipe (Courtesy WWPP Chile)*

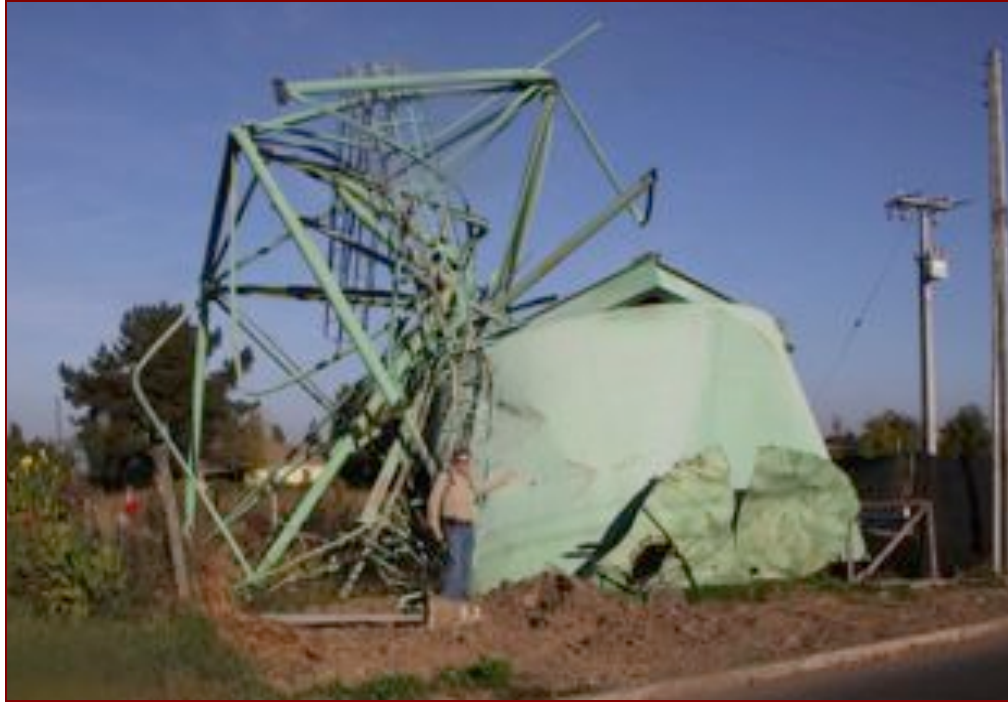
Over the past 50 years, the federal government of Chile has constructed nearly 2,000 small rural potable water systems country-wide, of which about 420 were in the strong earthquake-shaking areas. At least 73 of the elevated tanks completely collapsed. Tank failures were due to inertial overloads.

*Typical Collapsed Elevated Small Steel Tank (Constructed 1999)*

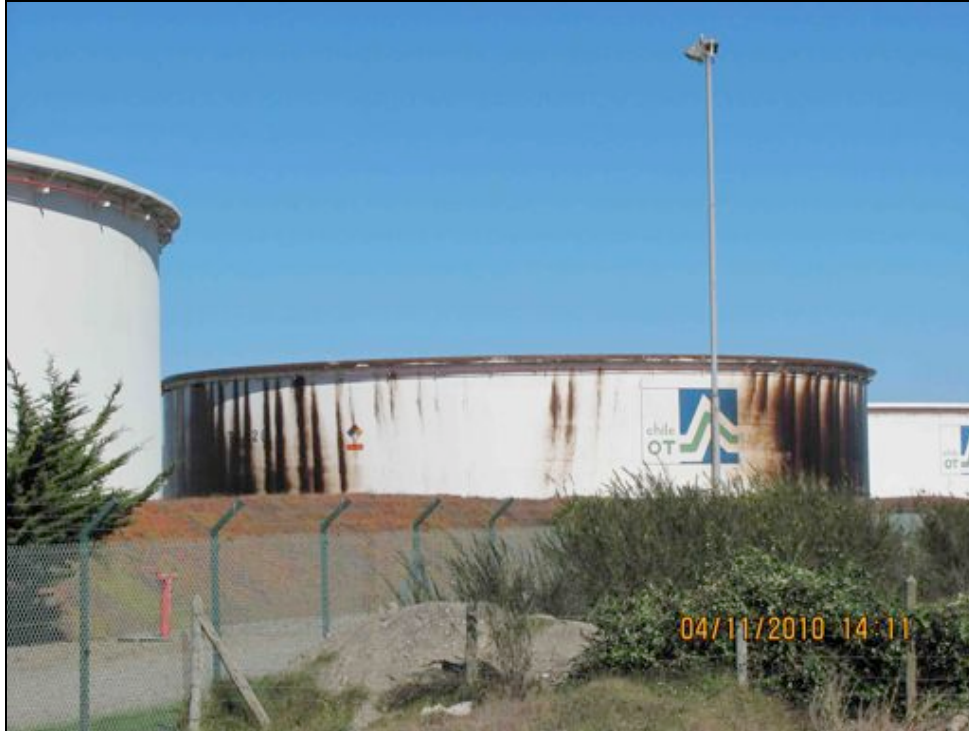
*Oil tank sloshing spill over the rim*

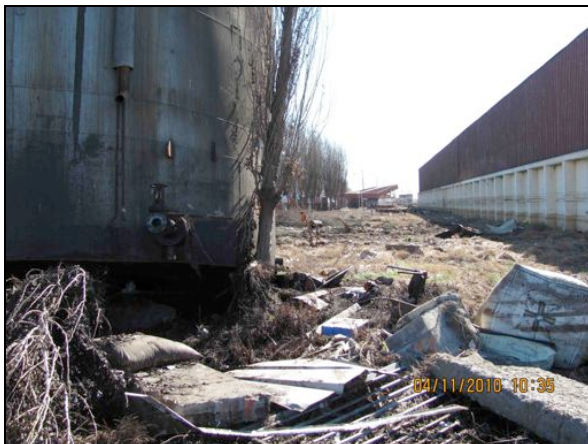
*This fish oil tank was moved 300 m by the tsunami*

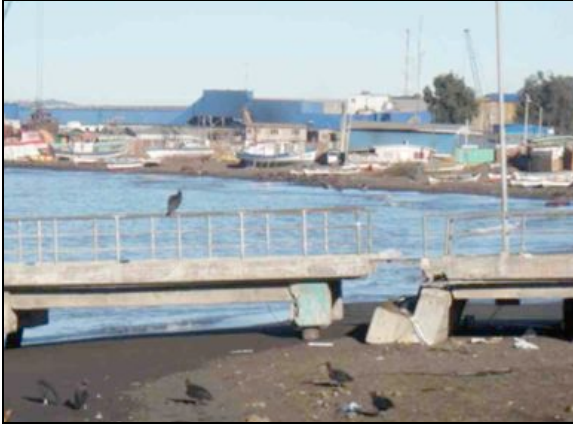
South of the main industrial Coronel Port, a pier used mainly for unloading goods by the fisheries industry was damaged by lateral spreading and was partially collapsed. Furthermore, the power supply cable for the crane at the end of the pier was severed. We understand that this pier will have to be replaced.

*Concrete pier moved towards shore due to lateral spread lateral spread*

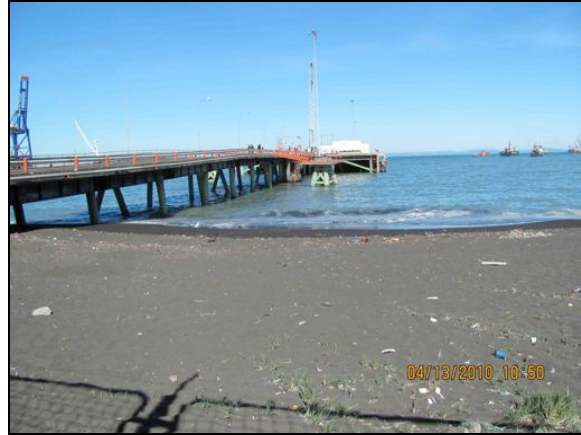
*Pier 1 at Coronel*

Pier 1 at the Coronel Port sustained significant damage to piles; a few piles had welds completely broken from the bottom of the pier deck. Supporting beams close to the abutment were deformed. Damage observed mainly was due to poor soil conditions and permanent ground deformation and lateral spreading. Pier 2 at Coronel was constructed with base isolation design and it had only very minor surface cracks around a few pier heads. The conveyor pier for transporting minerals from ships to warehouses was under construction and only suffered minor damage.

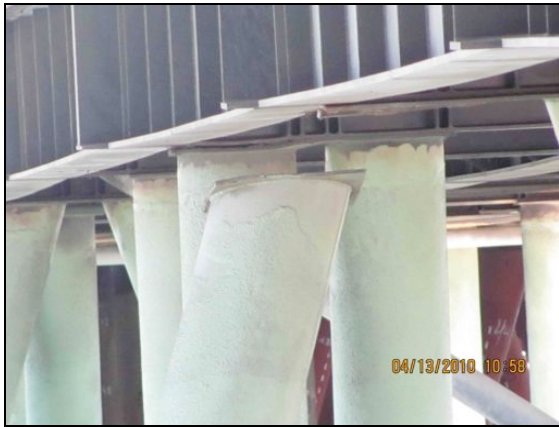
*Pier 1: a few pile supports with broken weld were observed*

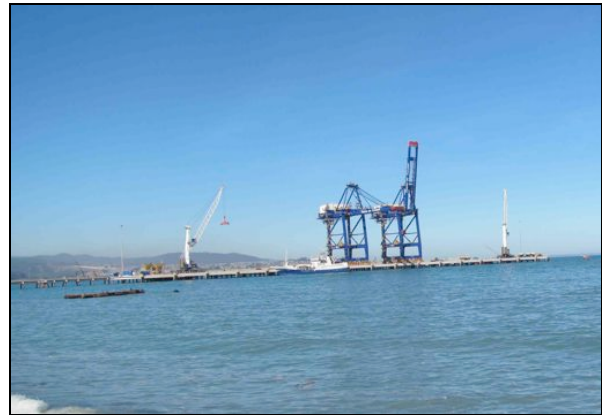
*Pier #2, a base isolated pier-the part of the pier where the cranes are located did not have any damage*

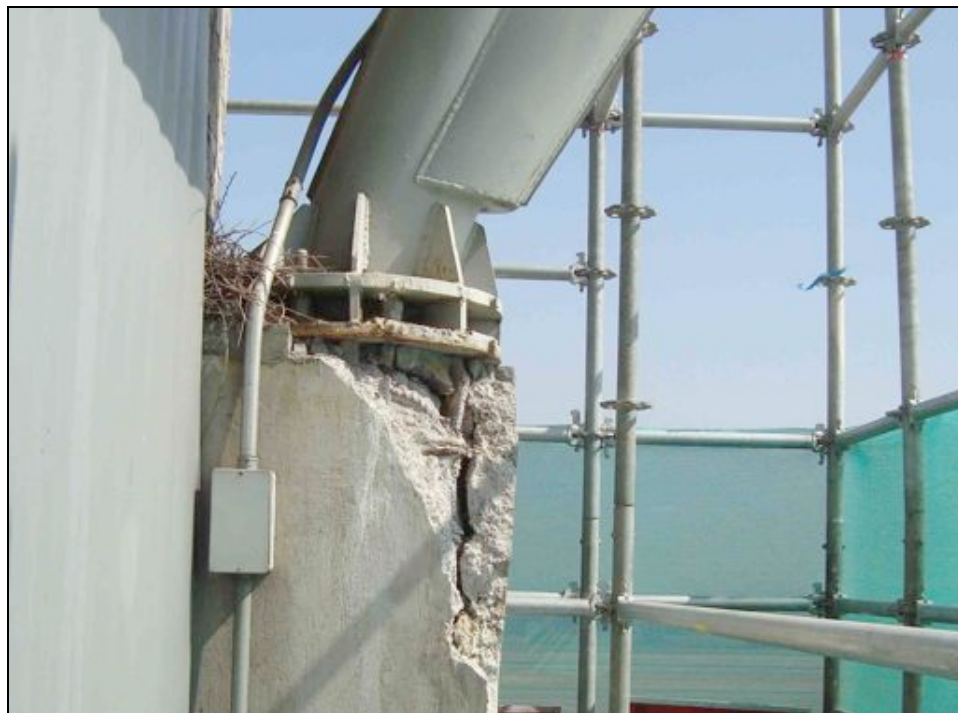
The mounting pedestal of the steel frame that connects the cab of the control tower to the concrete structure was damaged due to location of anchors too close to the edge of the concrete pedestal. Due to strong shaking the equipment in the cab was damaged. One wood equipment cabinet that was anchored to the concrete floor was sheared off at the base. Only two glass windows were broken. The traffic control has been relocated to secondary control tower until the main tower is repaired.

*Santiago Airport control tower damage of the four anchor points of the cab structure*

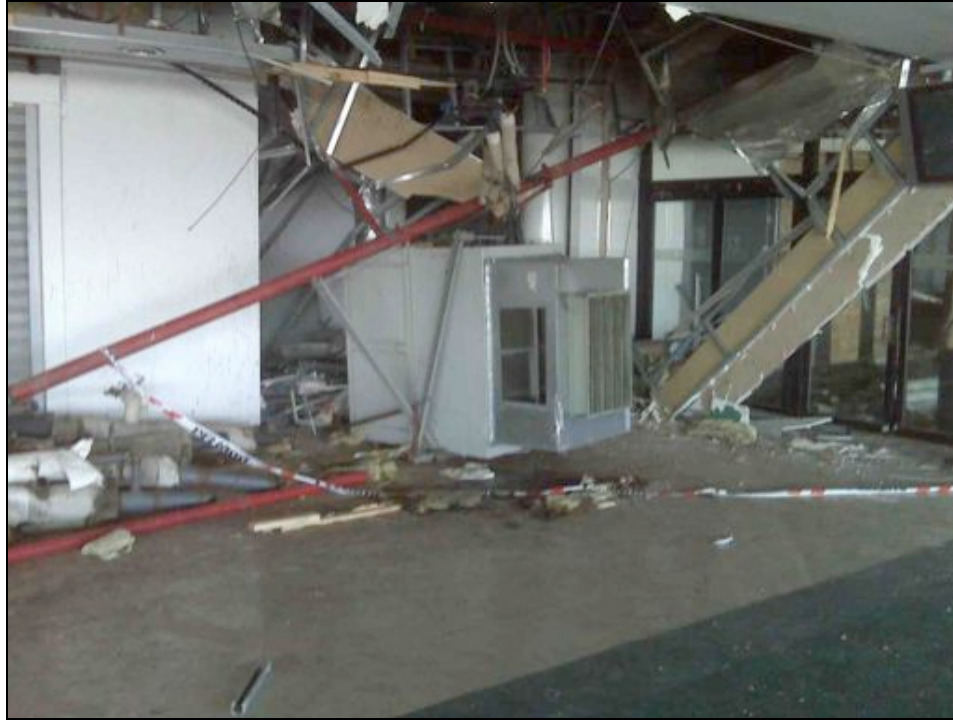
Santiago (Arturo Merino Benítez) International Airport was close for a week due to extensive non-structural elements damage in the passenger terminal building. In the departure hall (about 300 m long by 60 m wide), all the ceiling tiles fell. A few pipes in rest rooms were broken. Light fixtures were damaged. HVAC equipment and ducts were shaken loose from the ceiling and fell. A few glass windows were broken or shaken loose. The only structural damage was the bridge connecting the terminal building to the overpass collapsed. If the earthquake happened during peak occupancy of the terminal, many injuries and casualties could have resulted from these fallen objects.

*Non-structural damage of Santiago Airport passenger terminal on the departure level (courtesy of Juan Pablo Muñoz)*

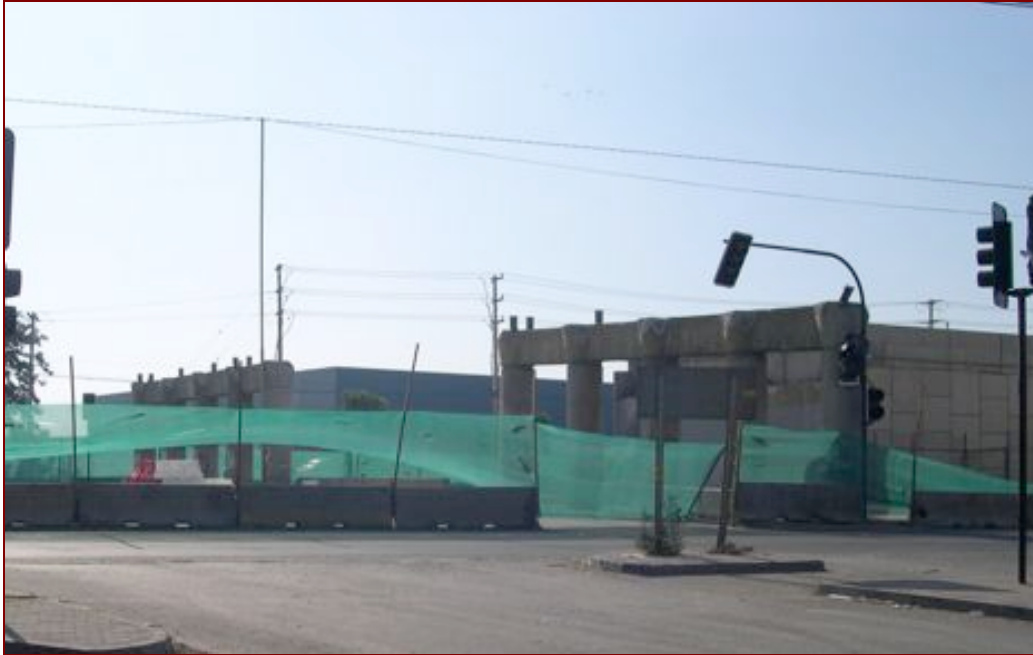
*One of the overpasses damaged, this is the highway towards Santiago Airport.*

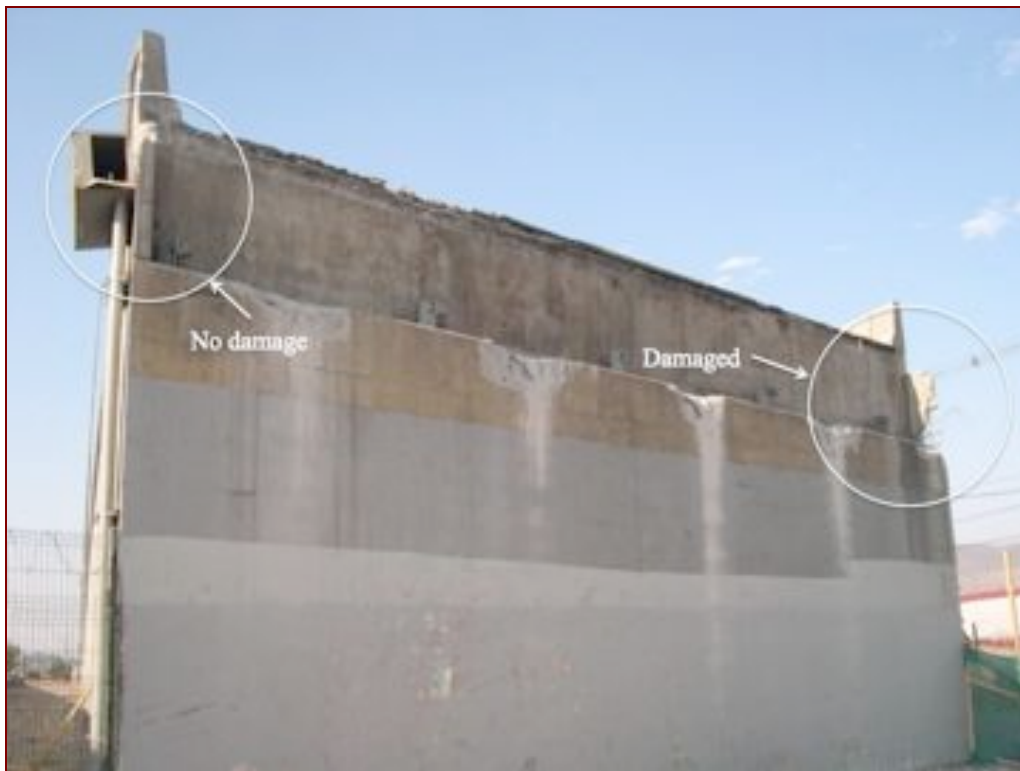
*Note the circled areas, showing rotation of the deck.*

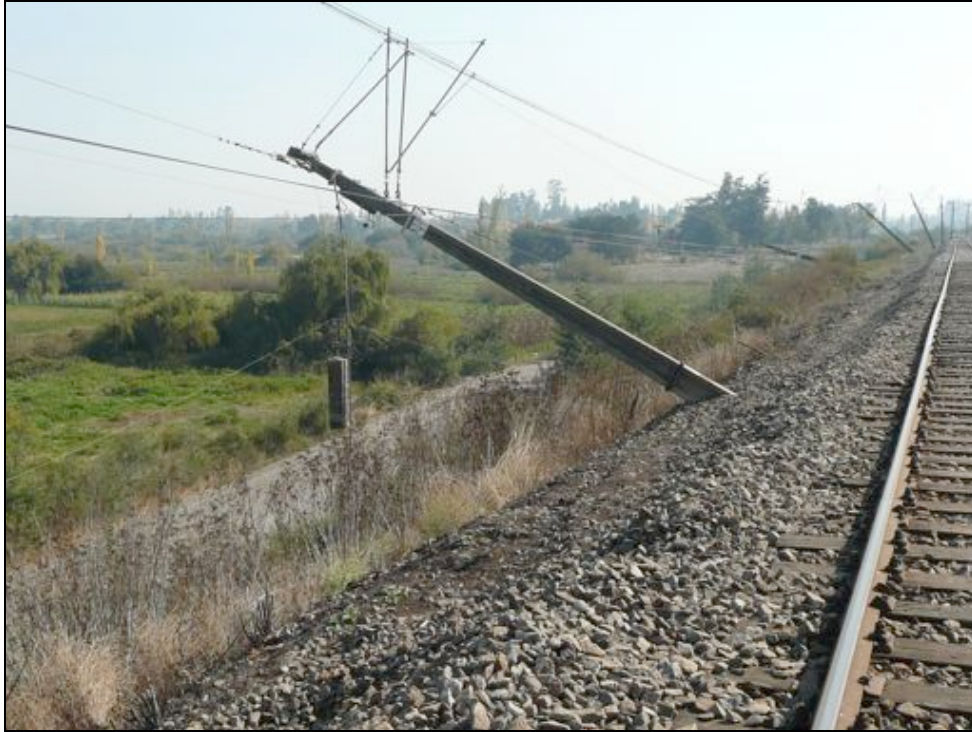
*Overhead power line for electric power rail cars failed*

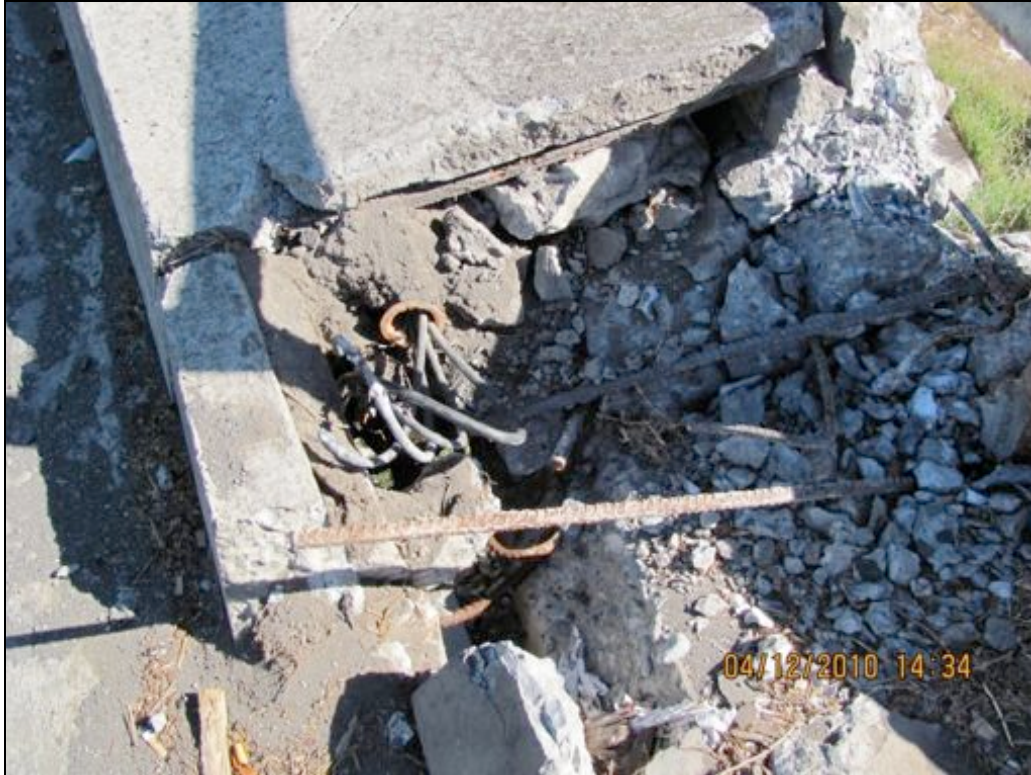
*Co-located power and telecommunication cables along the damaged Juan Pablo II bridge over the Biobío River in Concepcion.*
