Brief Report – EERI Clearinghouse – UCSD Team

Tara Hutchinson, Matthew Hoehler, Arnold Gastelum, Derrick Watkins and Richard Wood
4/12/2010

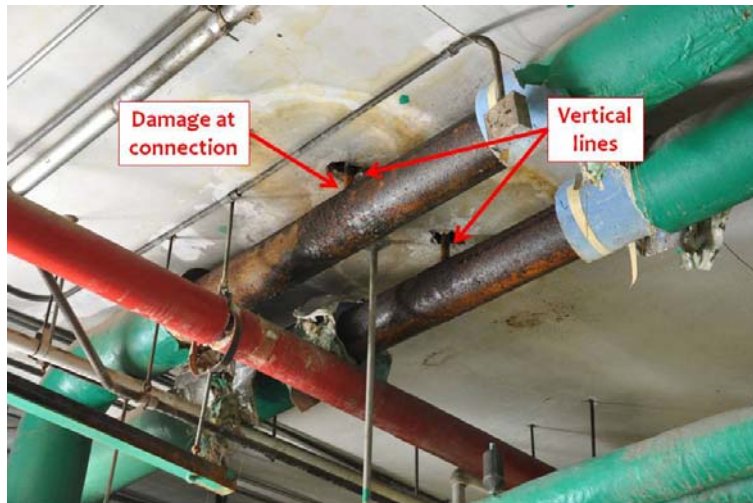
Figure 1. Repaired chill lines in one-story wing of the El Centro Regional Hospital, only minor nonstructural damage was observed in both the new and old wings of the hospital.

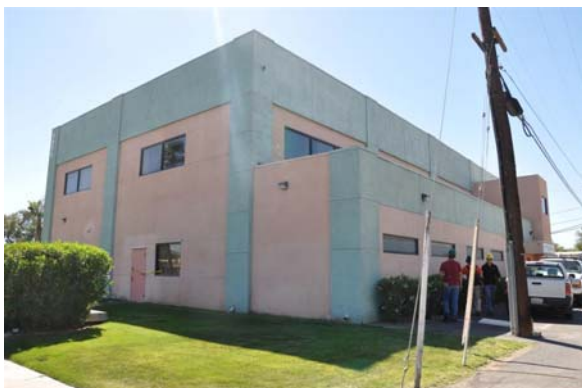
Figure 2. Red tagged medical plaza neighboring the El Centro Regional Hospital: (a) northwest corner and (b) typical facade cracking (west side). Extensive nonstructural damage was also observed in this structure.

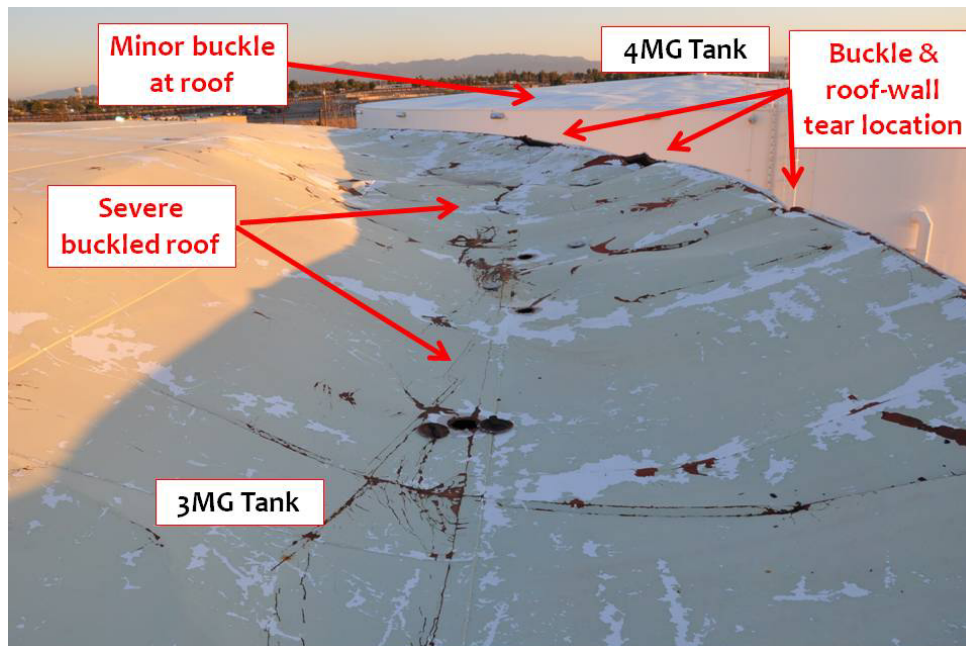
Figure 4. Damage to the 3MG tank west roof region (foreground), showing 4MG tank roof in background (image looking southwest) – Calexico Water Treatment Plant. (N32.6703°, W115.5048°)

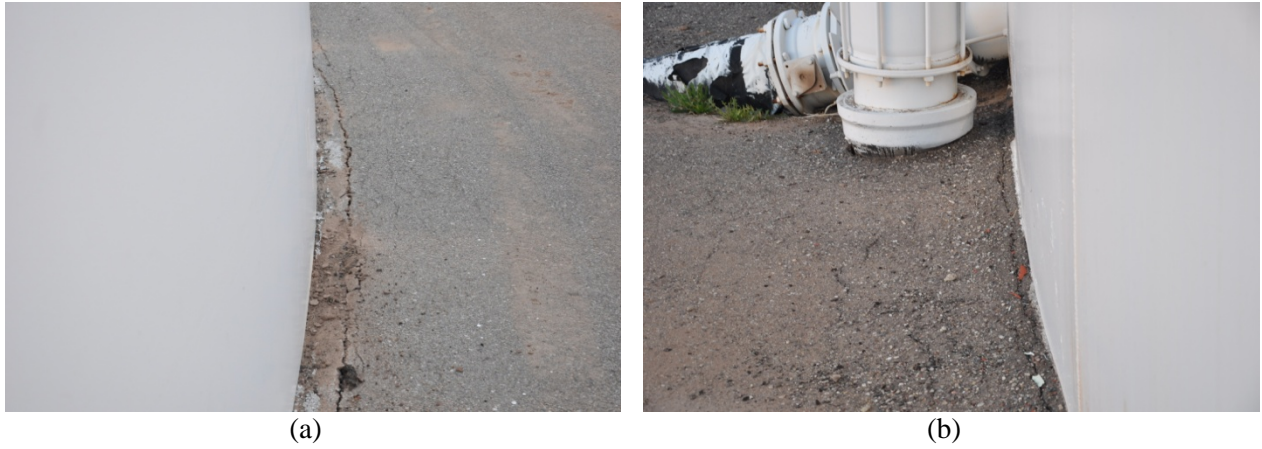
Figure 5. Evidence of dynamic foundation movement (a. N32.6703°, W115.5049°; b. N32.6704°, W115.5048°). (note cracks in pavement and separation between pipe and pavement). Calexico Water Treatment Plant.

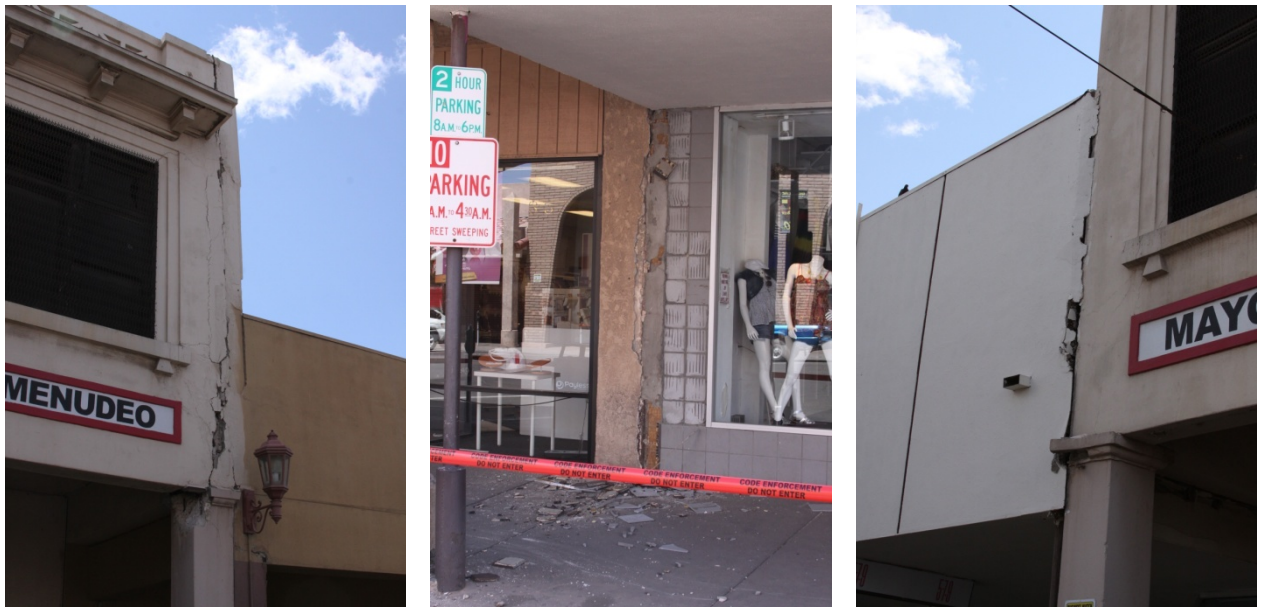
Figure 6. Damage due to impact of neighboring structure storefronts in downtown Calexico (images courtesy of professional photographer Joseph Llausas - taken April 5, 2010).

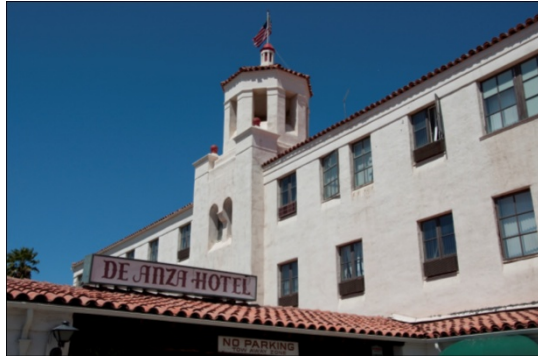
Figure 7. Damage observed at the Hotel de Anza within the city of Calexico, CA; (a) overview of front entrance, (b) significant cracks sustained just west of the tower section (1 = diagonal crack, 2 = vertical crack and 3 = horizontal cracks at floor levels) and (c) chimney damage on the east wall (N32.6689° W115.4956°).

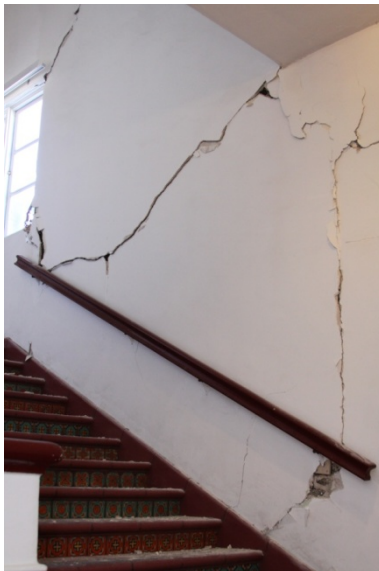
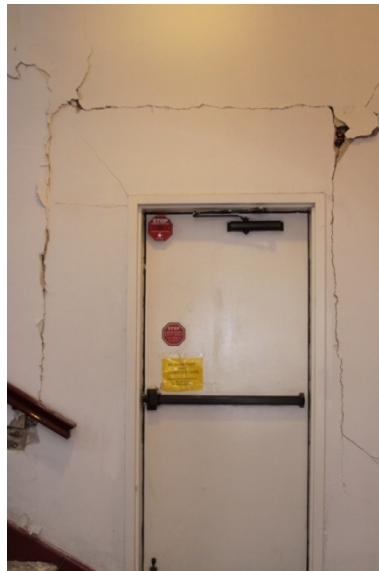
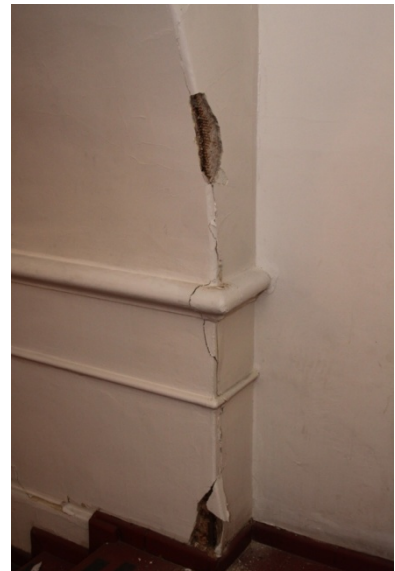
Figure 8. Typical interior damage of the Hotel de Anza in Calexico (images courtesy of professional photographer Joseph Llausas - taken April 6, 2010).

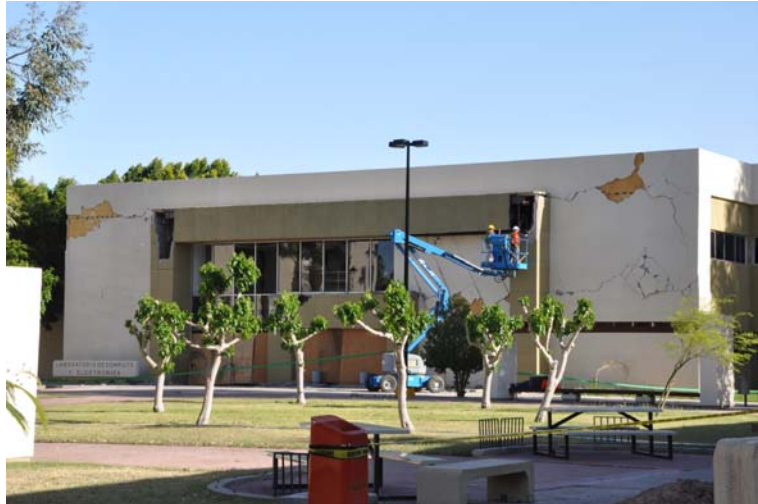
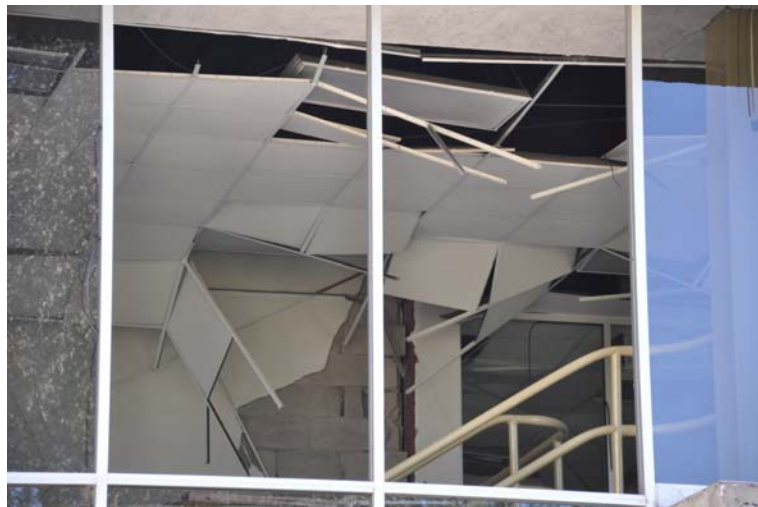
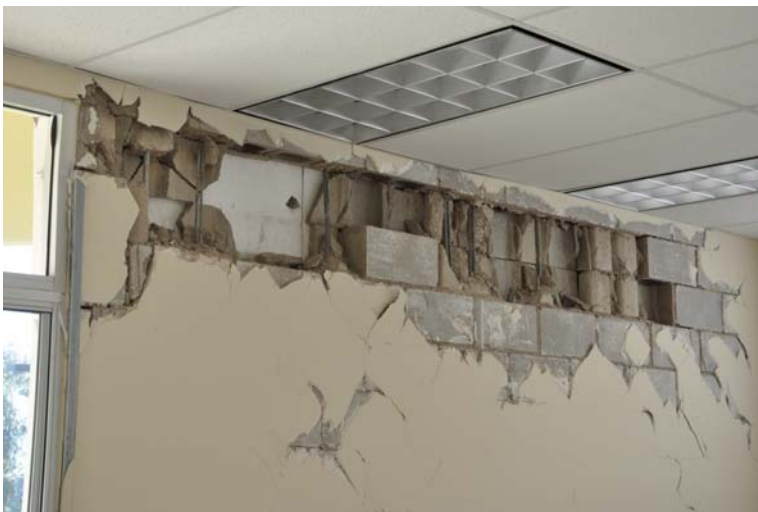
Figure 9. Damage at the UABC (Universidad Autonoma de Baja California (N32.6320°, W115.4444°): (top) typical exterior damage of low-rise masonry construction, (middle) interior ceiling damage, and (bottom) damage to partially grouted CMU walls.
