EERI Special Earthquake Report

M 6.0 South Napa Earthquake of August 24, 2014

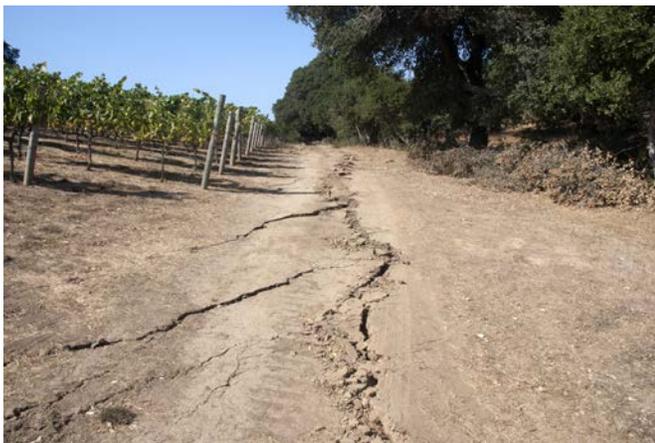
Displacements along the surface rupture are predominantly right-lateral and the rupture is highly variable in terms of expression at the surface. However, rupture is typically expressed as a zone of en echelon left-stepping fractures (Figure 8), varying from less than

Figure 8. Surface rupture west of Buhman Avenue, showing left-stepping en echelon fractures and mole-tracks. Right-lateral displacement was on the order of 40 cm, with a small amount (~12 cm) of up-on-the-west vertical displacement. GPS location: 38.2924°, -122.3432° (photo: Dawson et al., 2014).

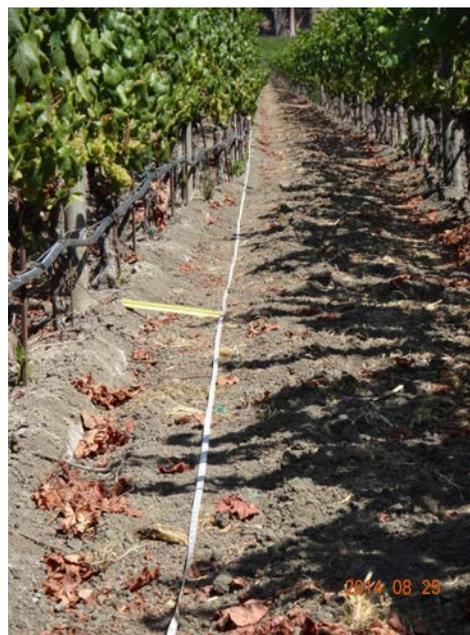
Figure 9. Surface fault rupture through vineyard about 6.7 km NW of epicenter, showing offset vineyard rows in area of maximum measured right-lateral offset of 40-45 cm (source: NSF-GEER; GPS N38.2776 W122.32377; 08/25/14: 2:23 pm) (photo: Keith Kelson, USACE).

At the latitude of Browns Valley Road, the rupture was observed along two subparallel, northwest trending strands approximately 500 m apart (Figure 9), with offset of 10- 20 cm on the western strand, and about 2- 8 cm on the eastern strand. North of Browns Valley, these strands appear to merge a few hundred meters south of Alston Park. The northern end of the rupture has been verified approximately 1.2 km north of Alston Park.

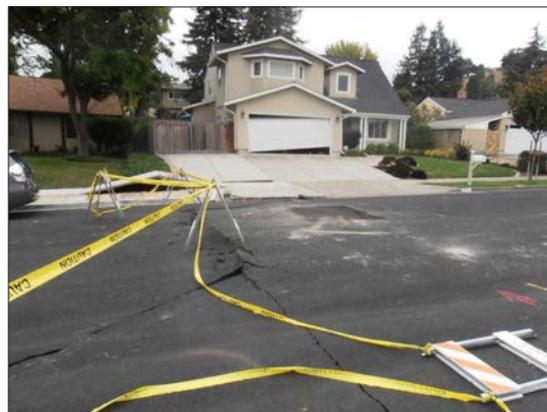
Geotechnical Effects. Surface faulting damaged homes, underground utilities, and other infrastructure where the fault traversed developed areas, such as the Browns Valley residential area in western Napa (Figure 13). Right-lateral surface fault rupture deformation in this area was on the order of 10 - 20 cm. The surface fault rupture damaged the house structure shown in the left photograph of Figure 14. The right photograph shows where the surface fault ground

movement displaced another house structure 6 cm from its foundation. Structures that were tied into the ground, e.g., pier and grade beam foundations, were damaged at a higher rate than ring-wall with suspended timber floor foundations.

Figure 14. Effects of surface fault rupture on infrastructure in Browns Valley area; left--home severely damaged (NSF-GEER; N 38.3025 W122.3436; 08/25/14), and right--foundation offset 6 cm (NSF-GEER; N 38.3038 W 122.3430; 08/25/14) (source: Bray et al., 2014).

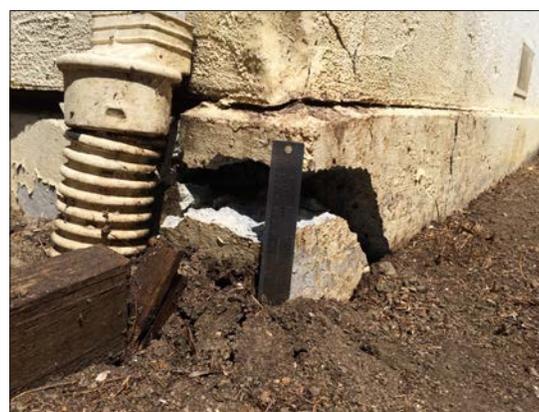
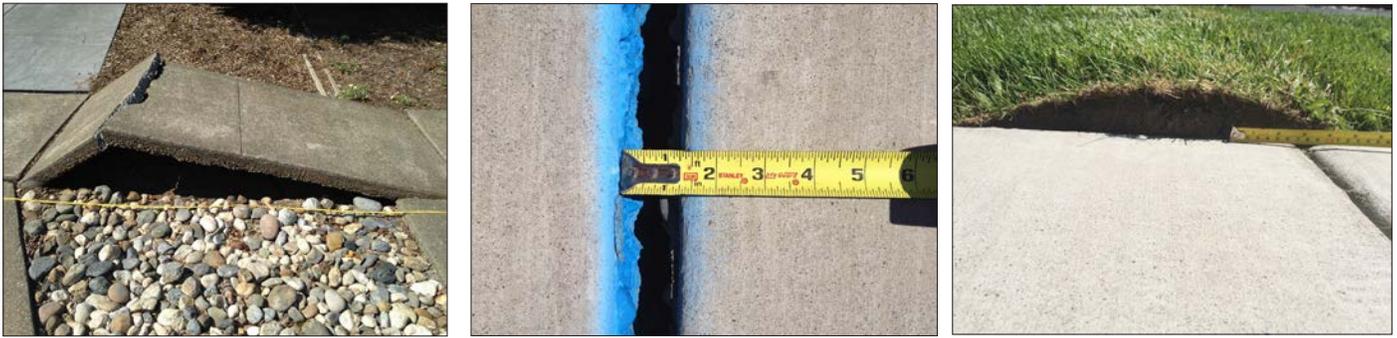
A distinct damage mode involved compressional and extensional failures within relatively new, stiff concrete sidewalks and curbs off of the primary fault trace throughout the Browns Valley area (Figure 15). Newly placed sod with a geotextile backing was warped in places similar to what one might see when a rug is shaken from one end. The sidewalk failures appeared to be a manifestation of localized zones of compression and extension distinct from the surface fault rupture, and possibly induced by intense transient surface waves. Other potential mechanisms are ground deformations associated with surface faulting or lurching of compacted earth fills.

Figure 15. Top--buckled sidewalk (NSF-GEER: N38.3039 W122.3430; 08/25/14); middle--sidewalk cracks (NSF-GEER: N38.3064 W122.3456; 08/28/14); and lower--warped sod (NSF-GEER: N38.3065 W122.3455; 08/28/14) indicating compressional and extensional zones in compacted fill near fault trace in Browns Valley area. (source: Bray et al., 2014).

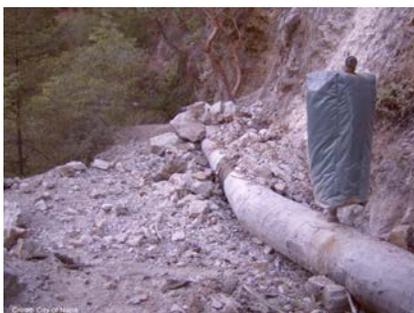
Figure 18. Milliken line, broken by rock slide (photo: City of Napa)

breaks in the system; there were 163 breaks, 75% of which were in cast iron pipe. Among the more significant breaks was that in the main transmission pipe from the Milliken source, which was broken by a rock slide, Figure18.

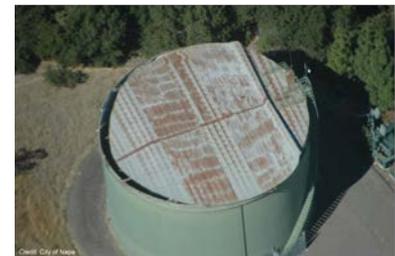
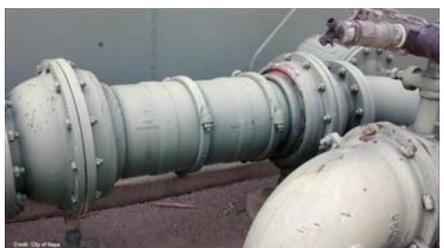
Of the 12 tanks in the system, one (termed Montana “B”) sustained significant damage, Figure 19. The tank is an unanchored 67’ diameter, 37’ high circular welded steel tank with corrugated iron (CGI) roof supported by redwood beams on steel columns. The water sloshed with approximately 6’ amplitude, damaging the roof. There was no buckling of the walls, but some rocking was evidenced by motion at the outtake slip joint. The tank drained immediately following the event due to a nearby pipe break.

Figure 19. Montana “B” tank. Upper photo--roof damaged by sloshing; lower photo-- outtake exhibiting evidence of motion at slip joint (photo: City of Napa).

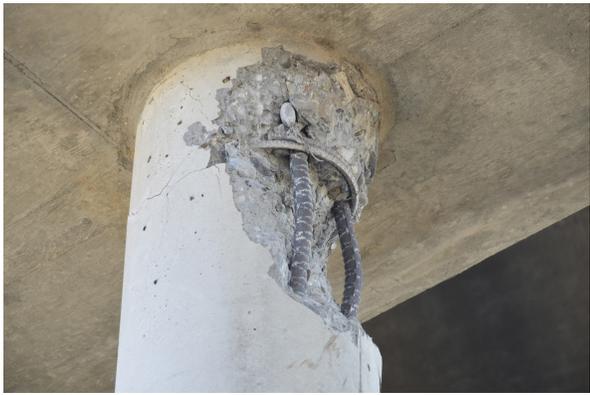
Figure 27. lower photo--Napa Slough Bridge; upper photo--typical damage to pile extensions on the Napa Slough Bridge (photos: Mark Yashinsky).

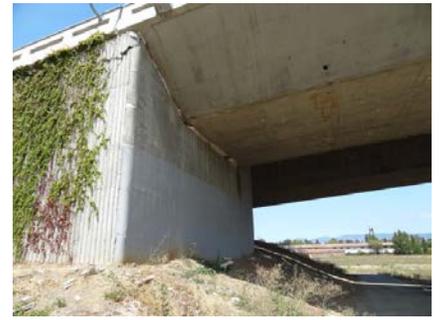
Most of the damage to state bridges was due to opening and closing of expansion joints, and the banging of wingwalls and barrier rails

Figure 28. Banging at abutments on the Napa River (W. Imola Ave) Bridges (photo: Mark Yashinsky).

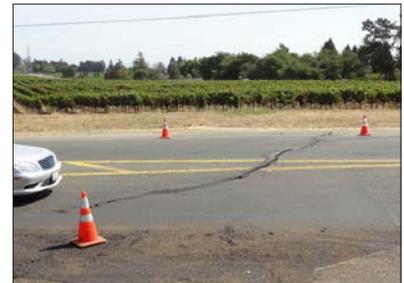
Figure 30. Fault offset across State Route 12 (photo: Mark Yashinsky).

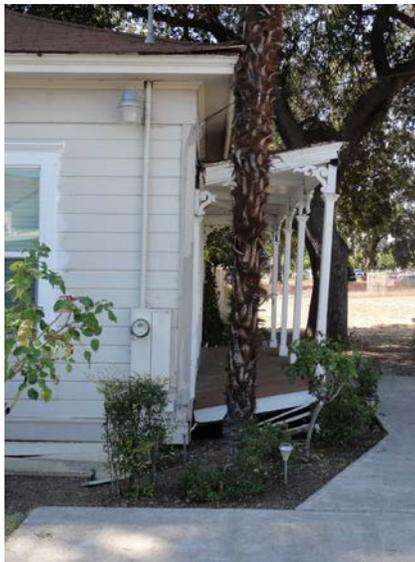
Figure 31. Cripple wall failure of single-story house west of downtown Napa. House fell in northwesterly direction (photo: Betsy Mathieson).

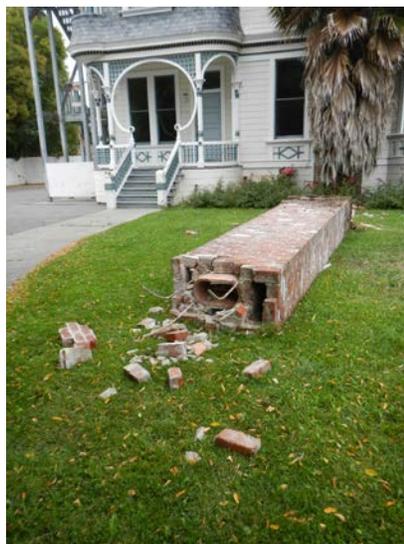
Figure 32. Chimney collapse near downtown Napa. Chimney failed at roof line of two-story Victorian house (photo: David McCormick).

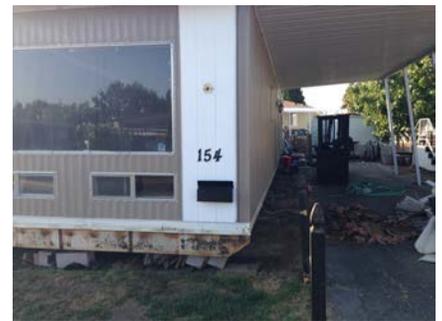
Figure 33. Foundation collapse in Salvador Mobile Estates northwest of downtown Napa. Mobile home displaced in westerly direction (photo: Mike Mieler).

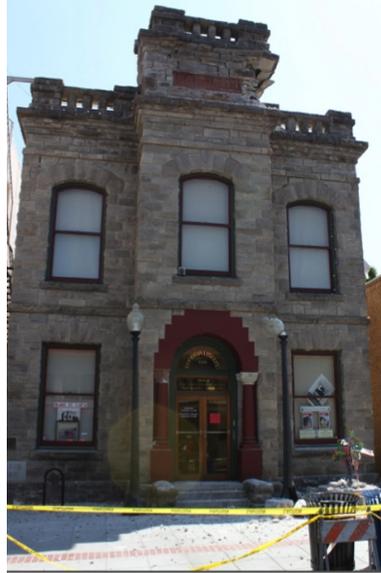
Figure 36. Turret damage in retrofitted stone masonry building (No. 12 in Figure 34; photo: Matt Schoettler).

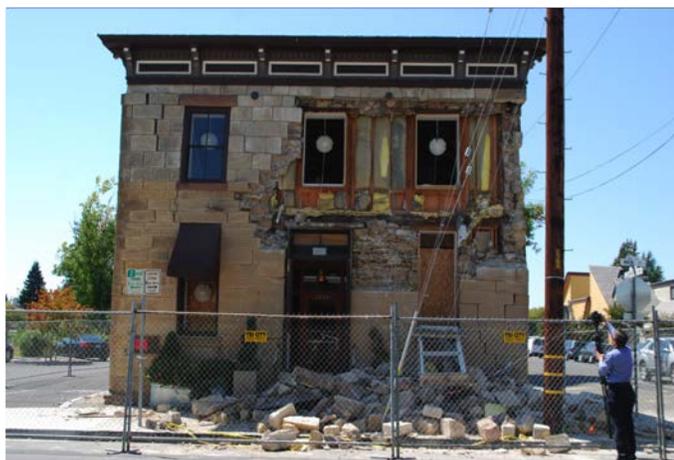
Figure 35. Historic stone masonry building damage (No. 21 in Figure 34; photo: Andre Barbosa).

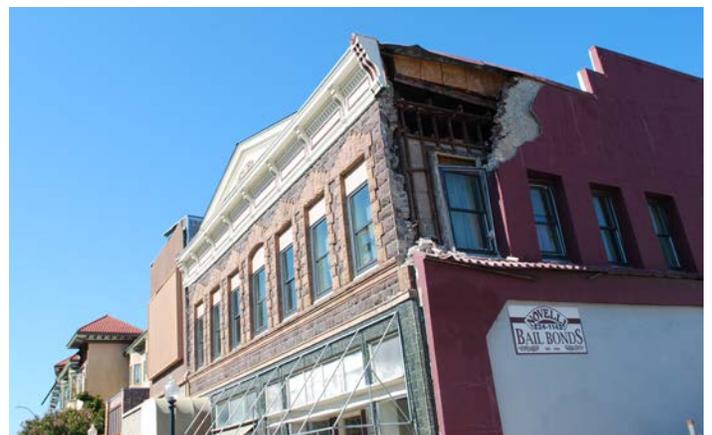
Figure 37. Out-of-plane failure in URM building (No. 1 in Figure 34; photo: Andre Barbosa).

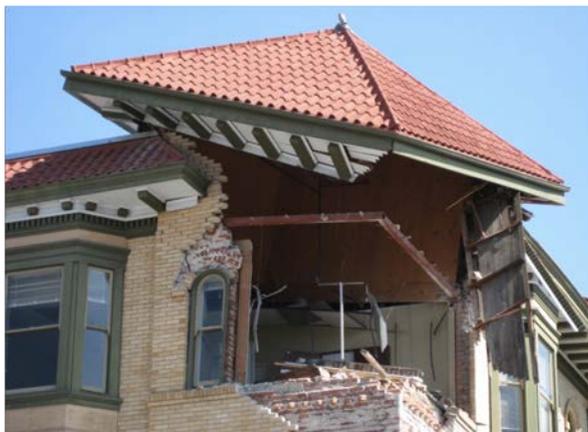
Figure 38. Out-of-plane failure in two-wythe masonry wall with brick veneer connected with straight adhesive anchors (No. 4 in Figure 34; photo: Karl Telleen).

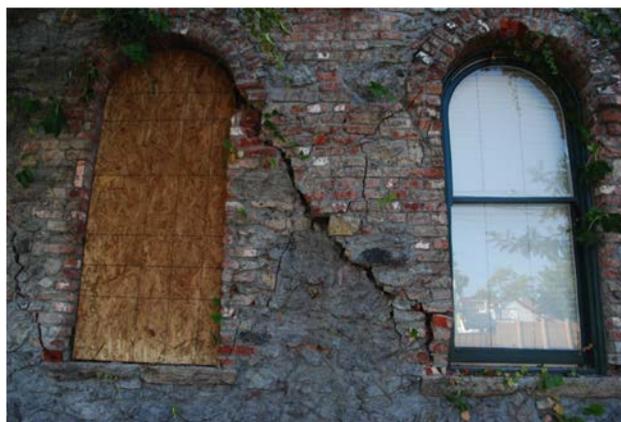
Figure 39. In-plane shear failure of masonry piers (No. 22 in Figure 34; photo: Andre Barbosa).

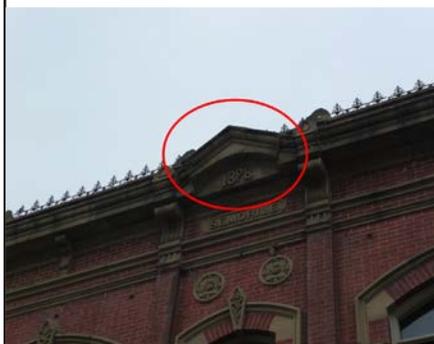
Figure 40. Retrofitted building with shifted cornice stone (No. 14 in Figure 34; photo: Marko Schotanus).

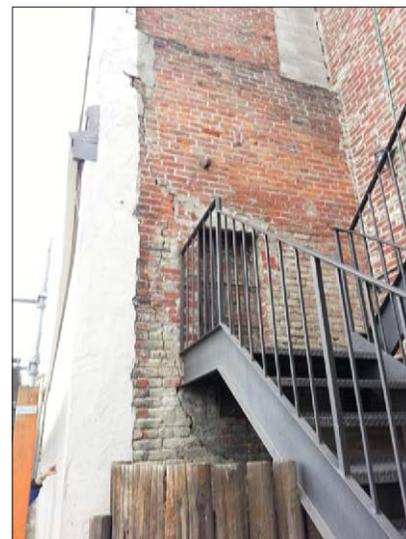
Figure 41. Wall damage caused by exit stair (No. 14 in Figure 34; photo: Bill Tremayne).

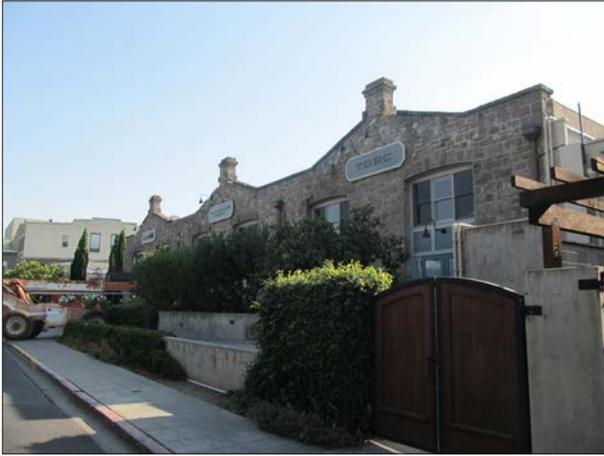
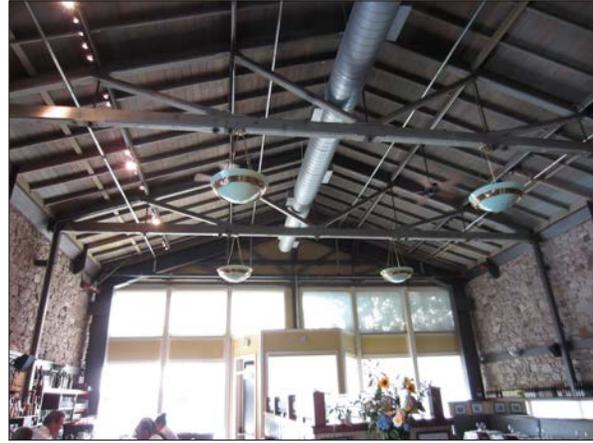
Figure 42. Comprehensive retrofit with minor damage in parapets (left), which led the building to be yellow tagged since the building was still accessible from the back (photo: Bret Lizundia); and (right) interior view showing no business interruption (No. 20 in Figure 34; photo: Bill Tremayne).

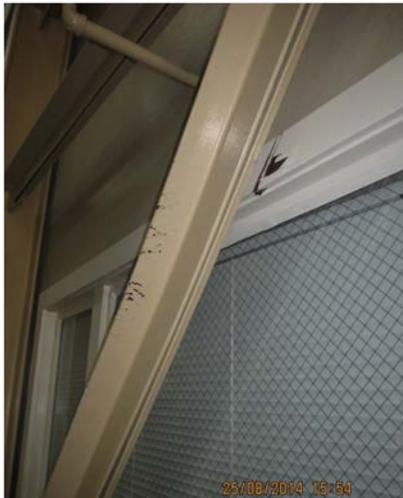
Figure 43. Buckled brace in URM with steel braced frame retrofit (No. 19 in Figure 34; photo: Andreas Schellenberg).

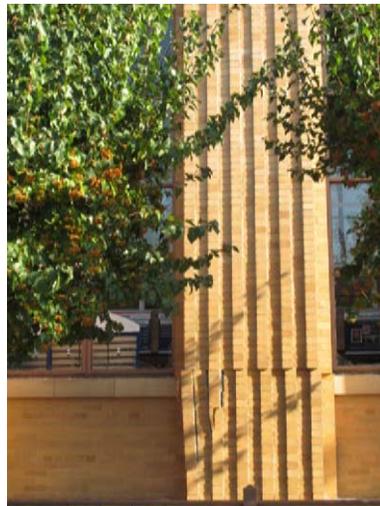
Figure 44. Steel frame with masonry infills: left--rocking wall pier with permanent offset (photo: Bill Tremayne); right--shear failure in wall pier (No. 26 in Figure 34; photo: Andre Barbosa).

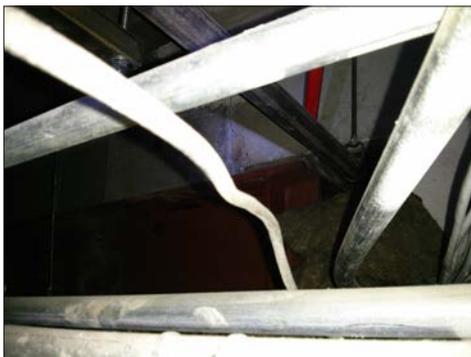
Figure 46. Left and right, precast beam and diaphragm connection damage at one location (photos: OSHPD).

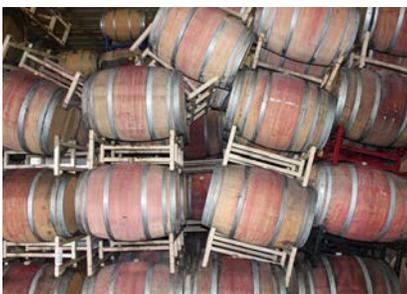
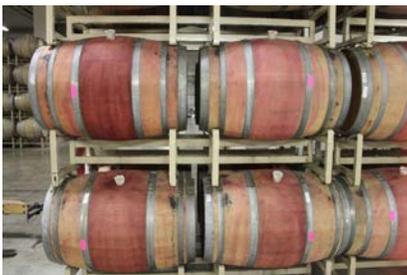
Figure 48. Collapsed stacks of barrels on “two-barrel racks” (top); stable stacks of barrels on four-barrel racks (bottom) (photos: Andy Yiu, Joshua Marrow).

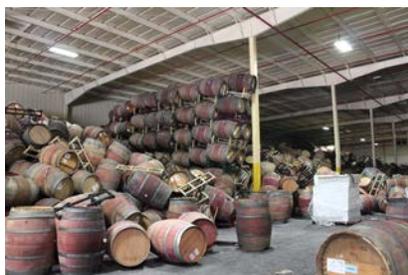
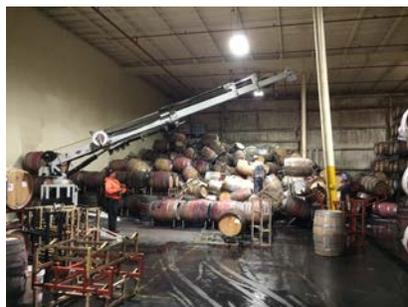
Figure 49. Collapsed barrel stacks leaning on interior column (top); a column knocked out of plumb by collapsed barrels (bottom) (photos: Andy Yiu, Joshua Marrow).

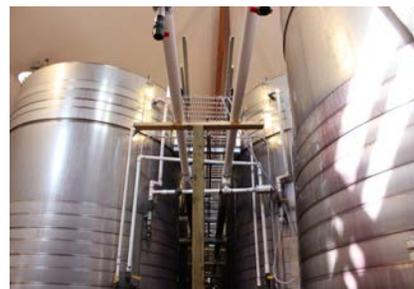
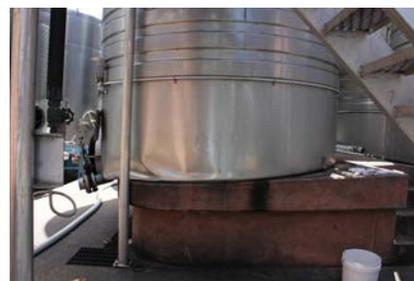
Figure 50. Stainless steel wine tank ruptured anchors, shifted 12inches, and buckled tank wall (bottom); tank-supported catwalk collapsed when tank (off to the left) collapsed (top) (photos: Joshua Marrow).

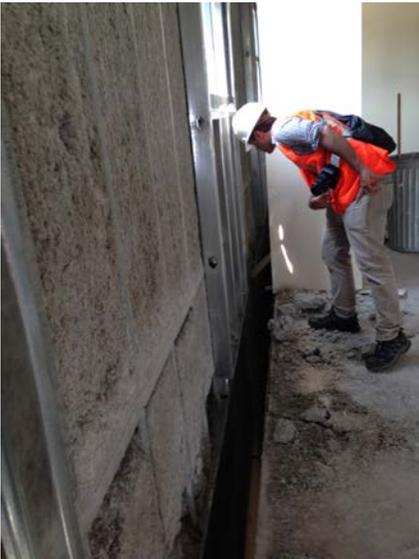
Figure 53. The metal studs supporting this stucco façade pulled away from the floors. The steel connection restraints were bent and the screws were torn out (photo: Lauren Biscombe).

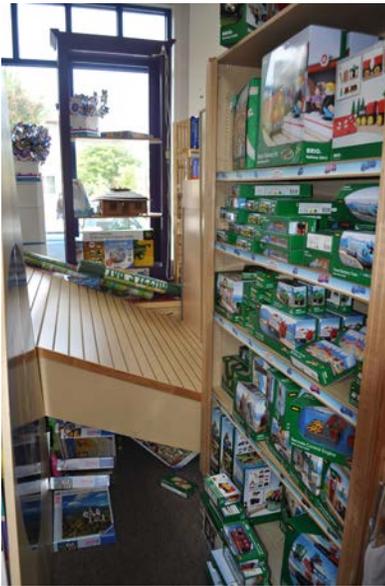
Figure 55. *Toppled heavy shelving unit in a toy store (photo: Ibrahim Almufti).*
