Notes and Observations of the South Napa Earthquake August 24, 2014

Case Study: Pre- and Post-Quake 3D Laser Scanning Of the Historic Gordon Building

By Shari Kamimori
October 16, 2014

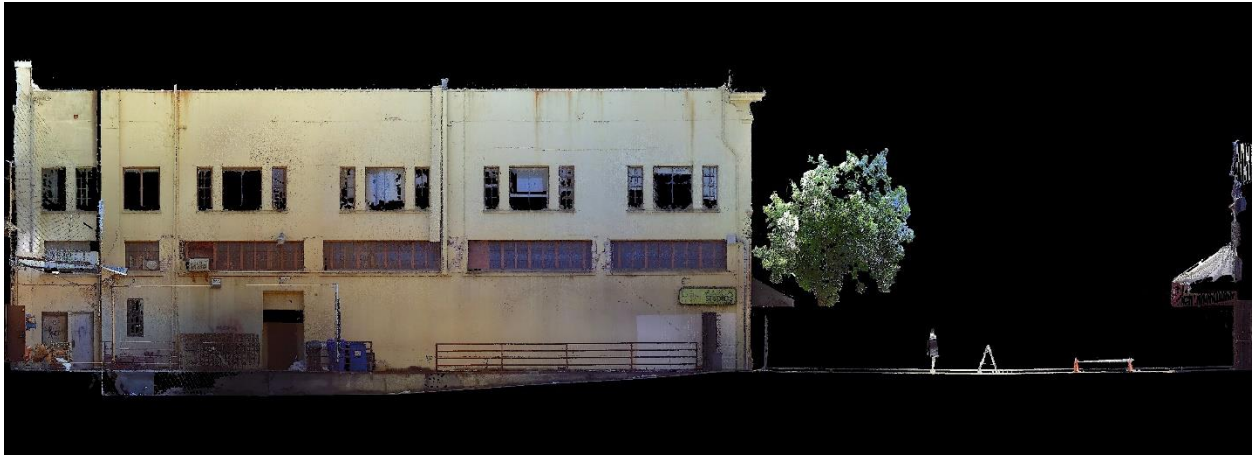
After the South Napa Earthquake on August 24, 2014, our team re-scanned the historic Gordon Building on September 3, 2014 in an attempt to compare and analyze the scan data pre- and post-quake. Figure 4 shows the north building façade.

Figure 4 – Post-quake photo-textured 3D Point Cloud

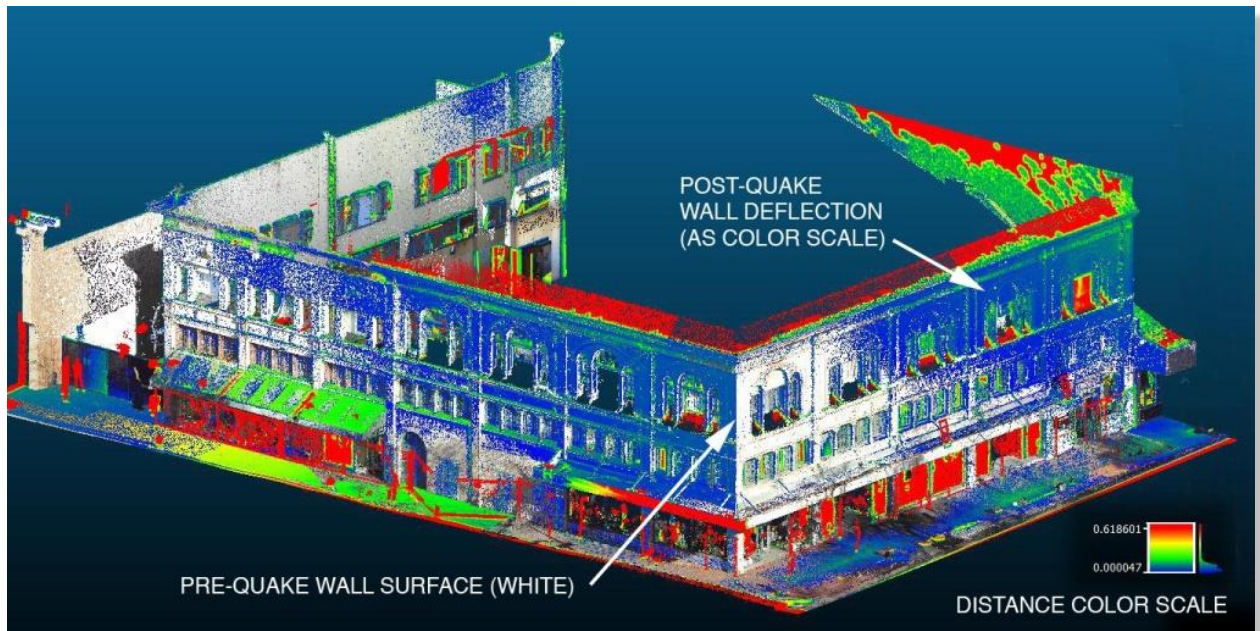
1. The distances are color-coded from blue to green to red to show the increasing distance between the two point clouds (Scalar Field Analysis).
2. The scalar field image shows how the walls are aligned at the lower corners, but then move gradually out of alignment from the lower street level to the diagonal upper cornice corner, as observed at the South and West wall surfaces, indicating the building's torsional rotation clockwise around the Z-axis (see Figure 5). **Note:** The red areas are where the pre-quake scan point cloud data was not captured when compared to the post-quake scan and is not indicative of displacement between the two point clouds.

Figure 5 – Post-quake South and West wall surfaces

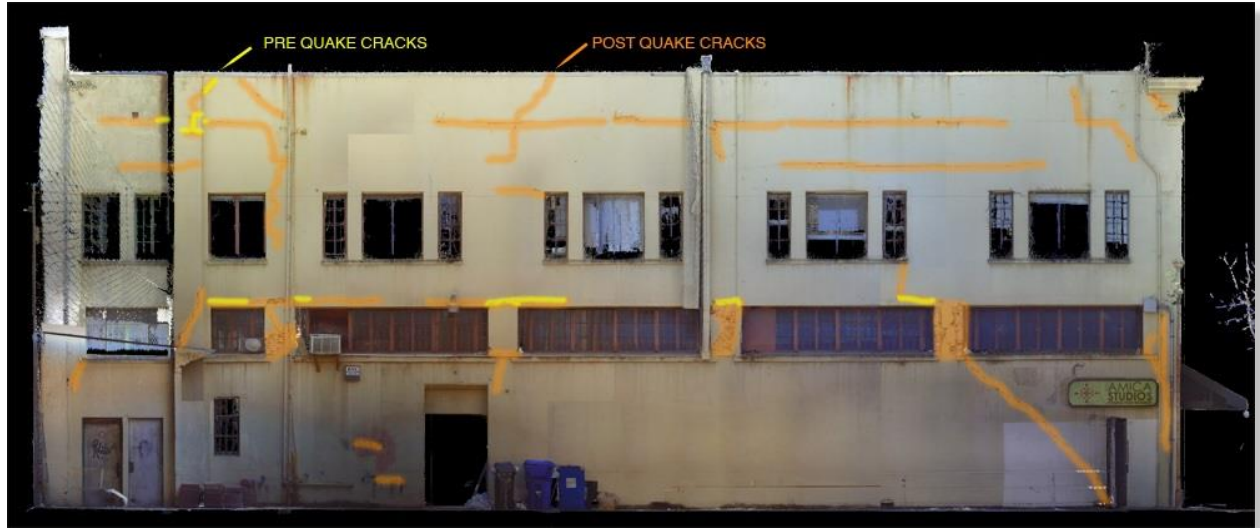
3. Building cracks pre- and post-quake are observed and can be measured (see Figure 6).
4. The Southwest profile and cornice detail shows a displacement of the cornice of approximately 1" (see Figure 7).

Figure 6 – Post-quake West wall showing pre- (yellow) and post-quake (orange) cracking

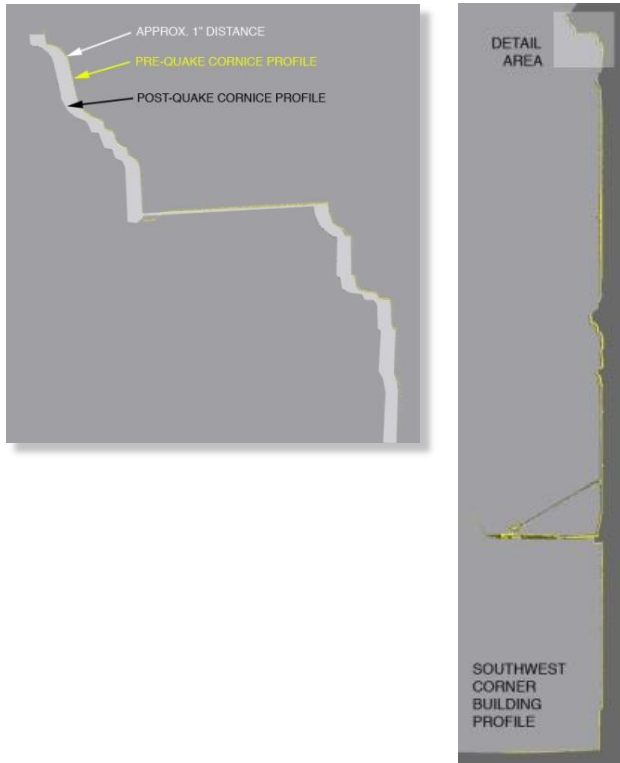
Figure 7 – Post-quake Southwest cornice profile detail. The yellow outline represents the scanned building profile.

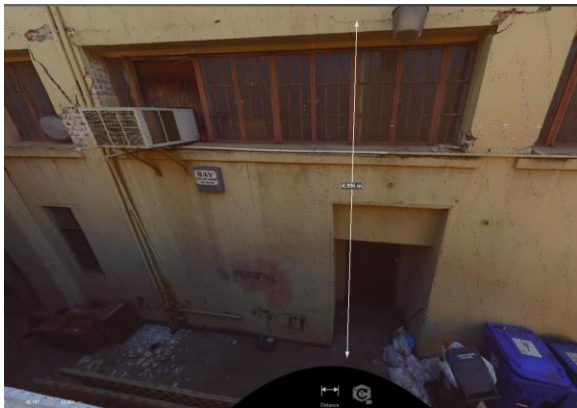
5. The long horizontal cracks were measured and compared to the 3D model / 2D drawings. The observation concludes that the cracking occurred below the floor/roof levels, which the dimensioning confirms (see Figure 8, 9 & 10).

Figure 8 – North wall Ground to underside Level 2 = 4.99m

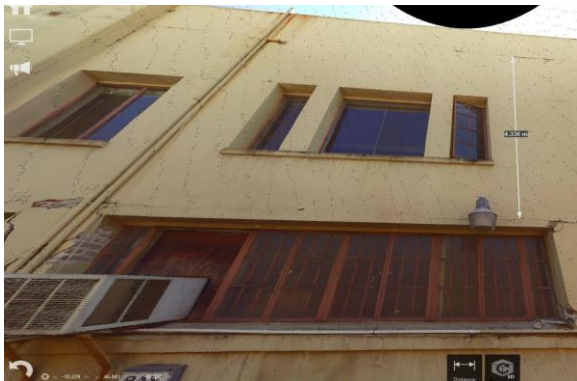
Figure 9 – North wall Level 2 to underside Roof = 4.33m

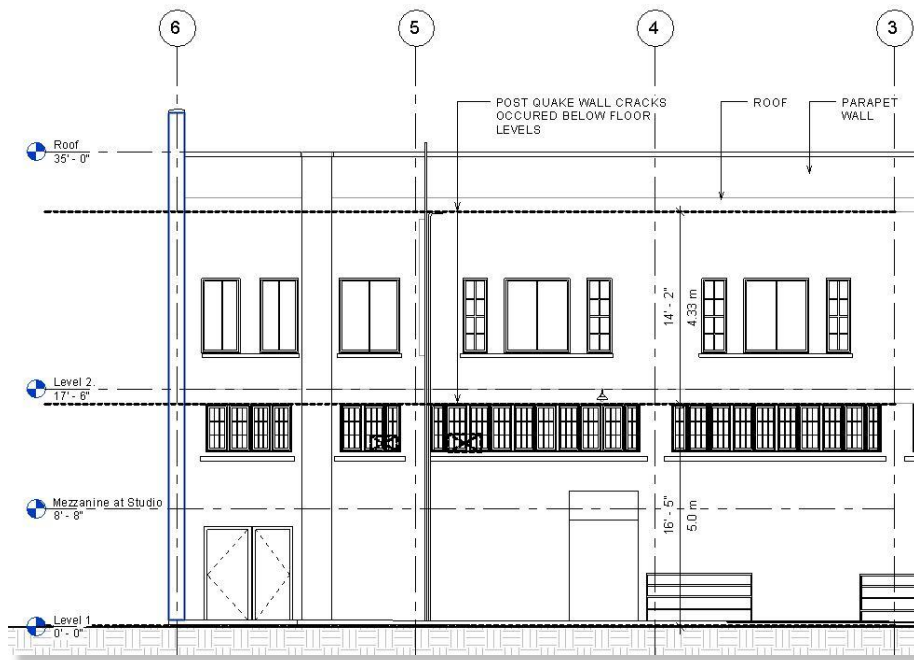
Figure 10 – North wall 2D drawing with dimensions showing below floor cracking
