# M6 SOUTH NAPA EARTHQUAKE

## August 24, 2014

MRP Engineering Summary Report

September 2014

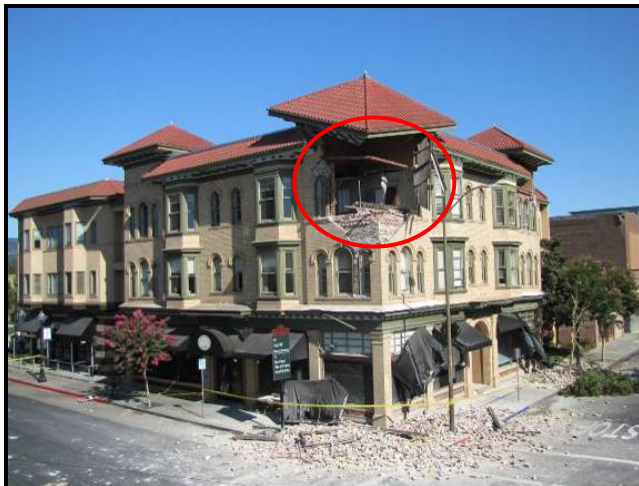
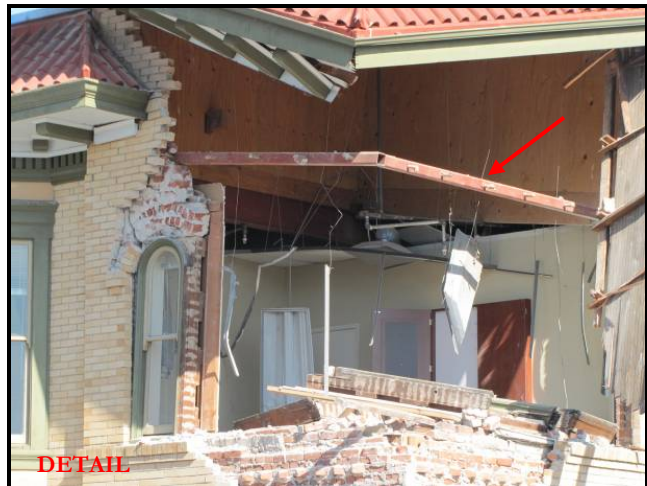
*This three-story structure includes an unreinforced masonry façade, a portion of which collapsed onto the sidewalk below. The close-up photo shows remaining wall anchorage connections below the roofline.*

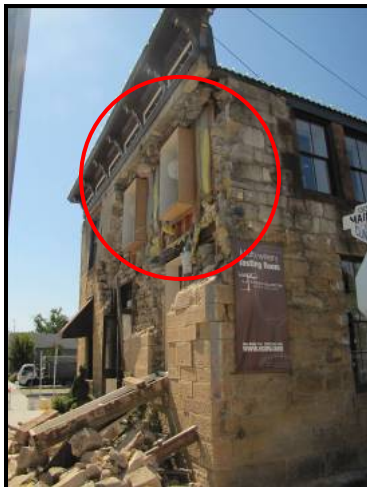
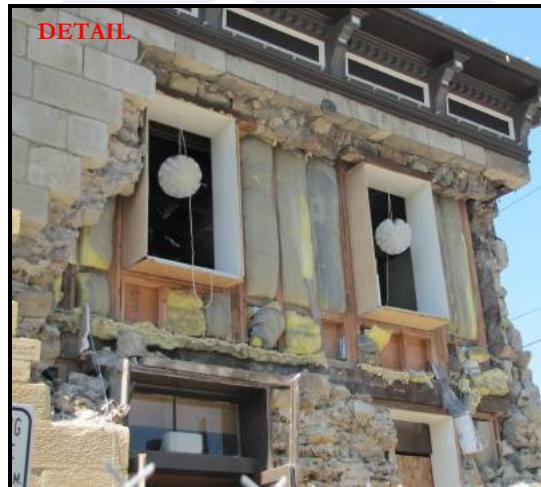
*Damaged 1875-vintage stone masonry building in Napa.  
Note wall anchorage (through bolts with steel plates) in the close-up photo*

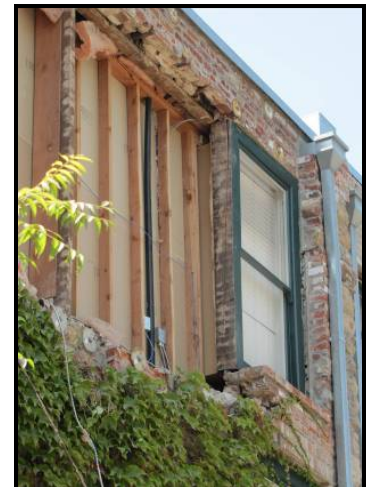
*Masonry wall failure in a building retrofitted with wall anchors at roof and floor levels.*

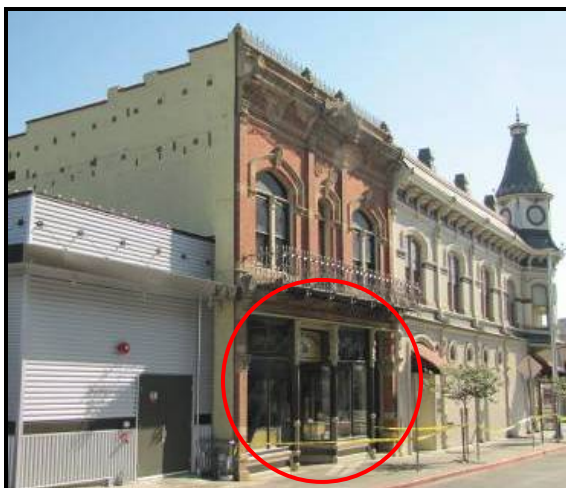
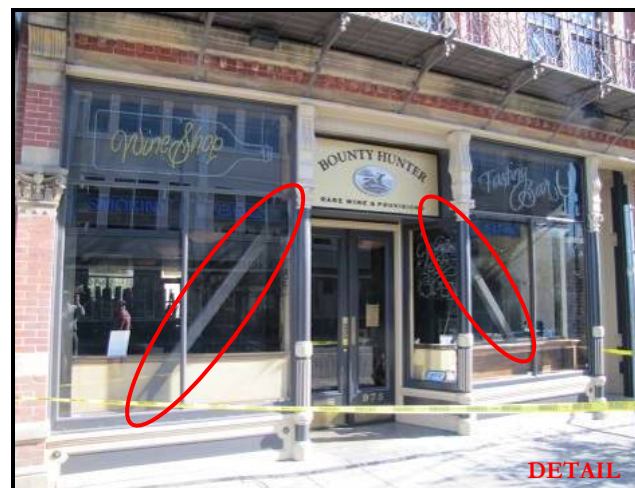
*Retrofitted URM building that survived the earthquake. Upgrades included wall anchors and a steel braced frame at storefront.*

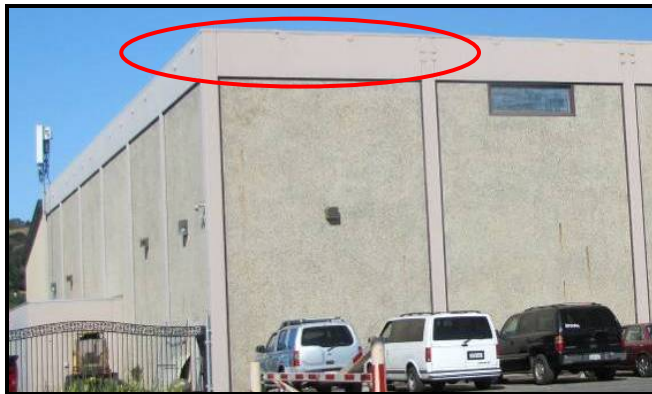
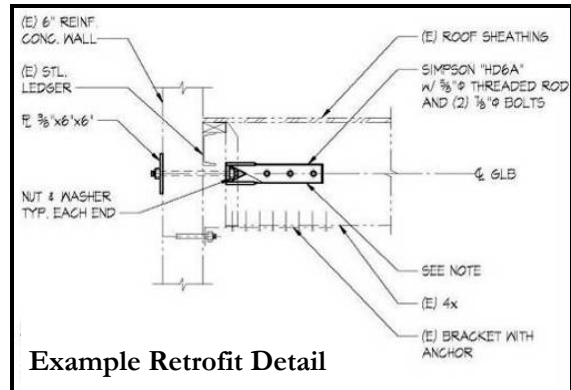
*Proactive upgrades of reinforced concrete tilt-up structures can be effective in preventing roof and wall separation. This building in Napa that survived the earthquakes was retrofitted with wall-to-roof thru-bolt connections.*

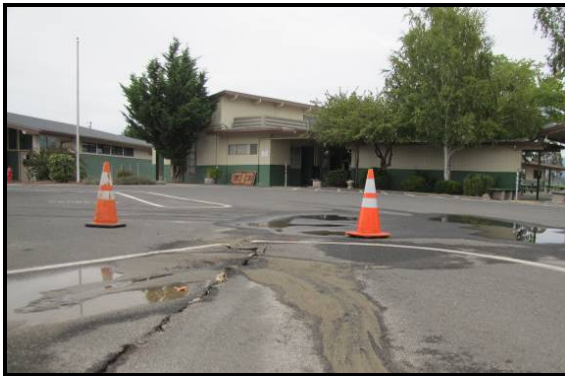
*Ground rupture in an elementary school parking lot south of Napa resulted in fracture of underground water piping.*

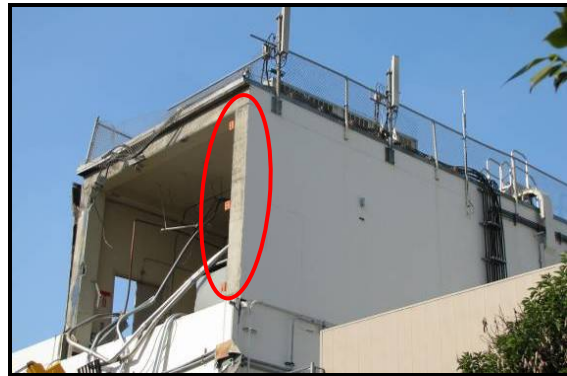
*Precast concrete wall panel connections failure at a local telecom hub damaged HVAC system at this critical facility.*

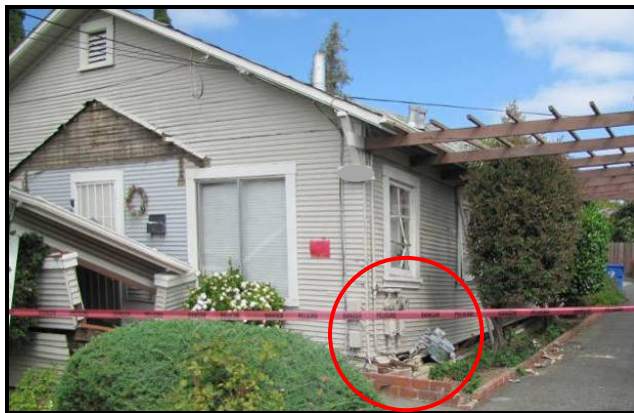
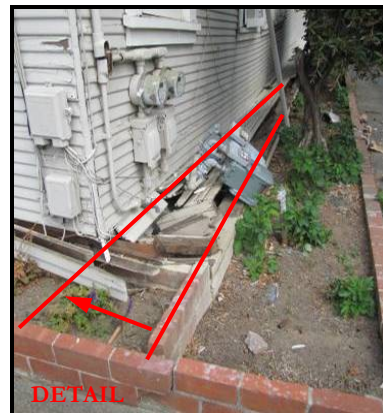
*Residential wood-framed structures that predate modern seismic design consideration can shift from their foundations when short wood-framed walls are present surrounding the crawl space below the main floor. These common failures can lead to a fire-following-earthquake hazard from severed natural gas piping and nearby electrical components. Correcting this condition involves installation of plywood sheathing with floor and foundation connections.*
