January 9, 2010 M_w 6.5 Gorda Plate Earthquake offshore of Northern California

Summary Report January 13, 2010 compiled from the USGS, Berkeley Seismological Laboratory, Times Standard, Humboldt State University, and the Redwood Coast Tsunami Work Group

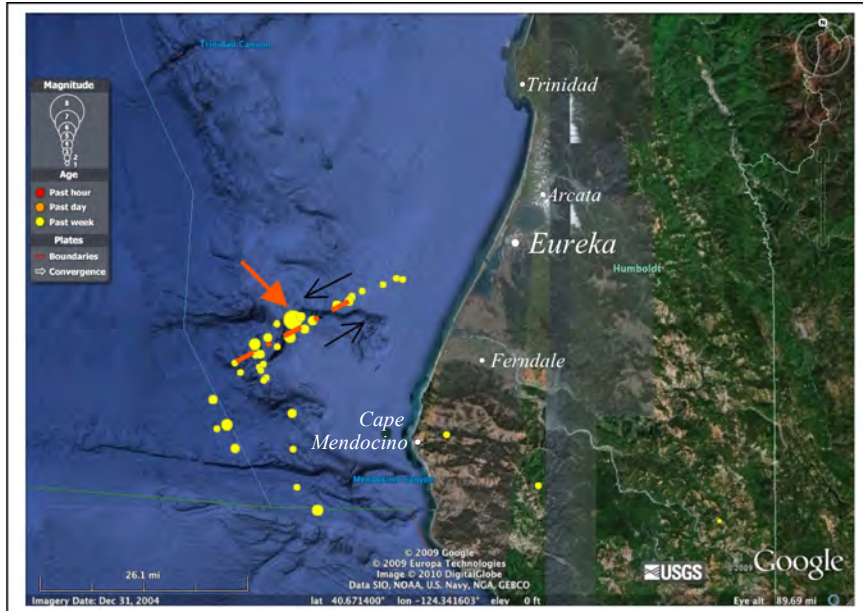
Google Earth image of the January 9 mainshock (arrow) and aftershocks as of 1/13. Dashed line shows the location of the probable fault source and black arrows show the direction of slip.

Inversion of seismic waveforms by the UC Berkeley Seismological Laboratory estimated a fault length of about 25 km (16 miles) and rupture proceeded unilaterally to the southwest. The peak estimated slip (offset) between the two sides of the fault was 2.4 meters (8 feet).

Thirty-nine aftershocks were detected in the first four days after the earthquake. Most were located along the 47° trend of the fault rupture (see figure above), but some were located in the SE Gorda plate south of the rupture and along the Mendocino fault. The largest was a magnitude 4.4 that occurred about an hour and a half after the mainshock. It was widely felt in the Humboldt Bay and Cape

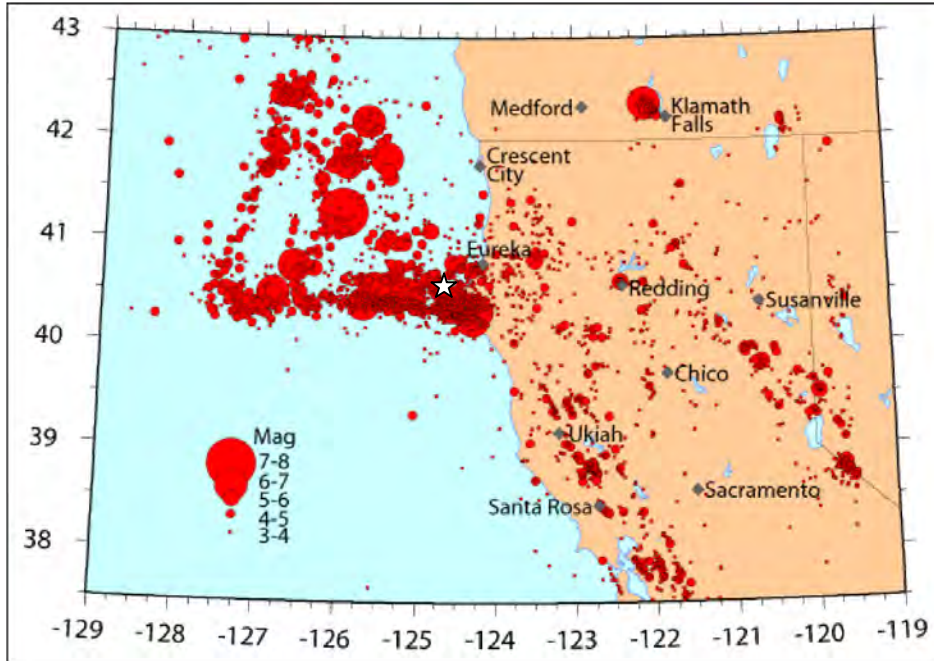
Historic North Coast Earthquakes epicenters 1975 to the present. Star shows the location of the January 9 earthquake.

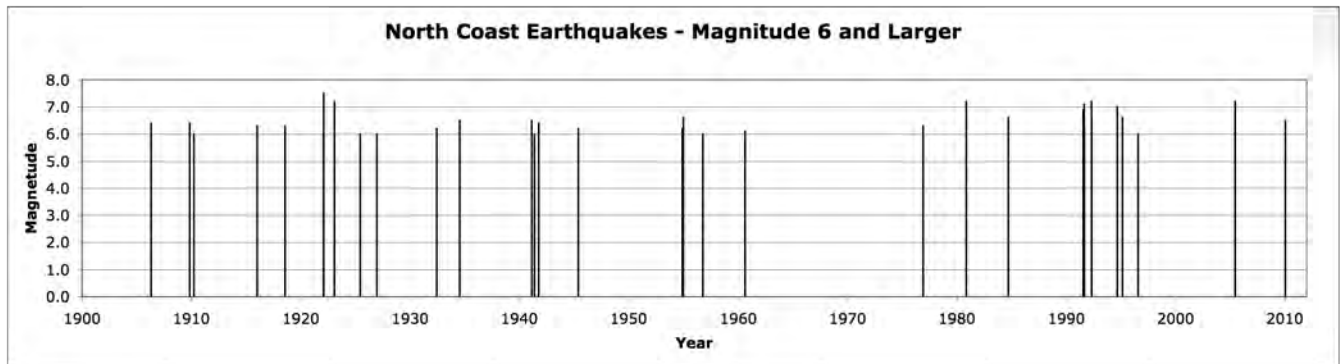
Historic North Coast Earthquakes of magnitude 6 or larger. Magnitude is a measure of the relative energy release at the earthquake source. It depends on the size of the fault and the amount of fault slip. Large magnitude earthquakes don't necessarily produce damage if they are located far from population centers.

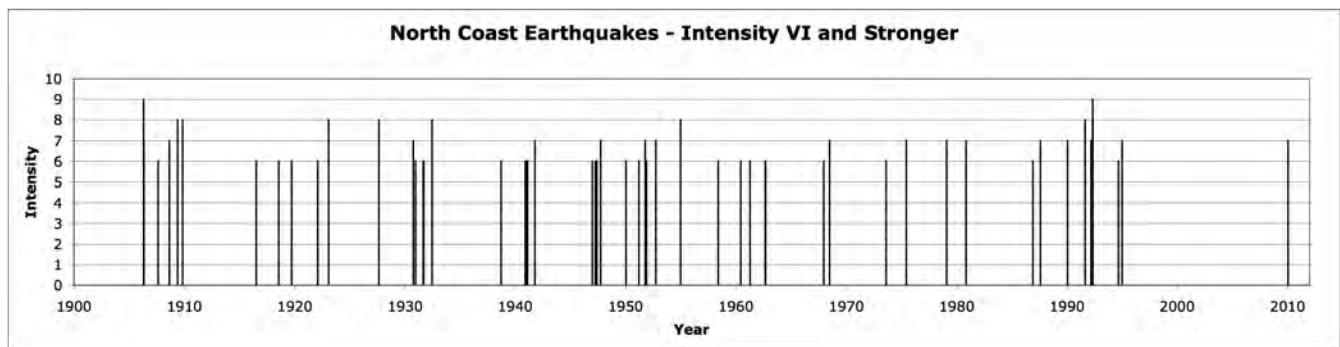
Historic North Coast Earthquakes of peak Intensity VI or larger. Intensity measures relative shaking strength at specific locations onshore. Intensity VI is considered very strong and may break windows and produce cracks in buildings. Intensity VII is severe and will topple many unreinforced brick chimneys and displace heavy furniture. Intensity VIII is described as violent and will knock unsecured structures off foundations and damage brick buildings. Intensity IX and larger is extreme and will damage even well-engineered structures.

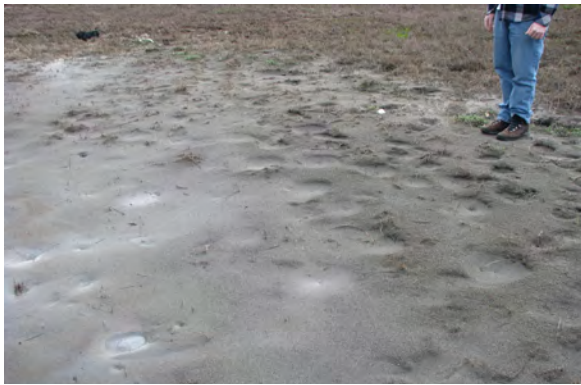
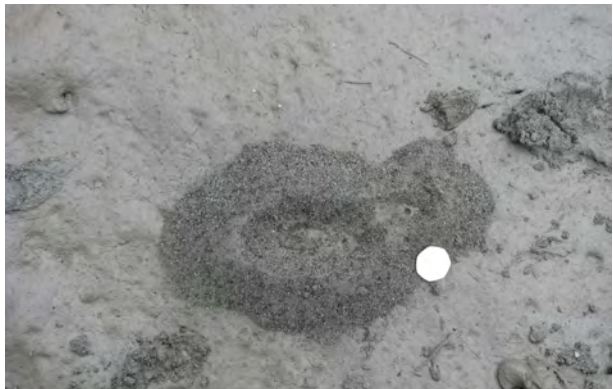
Liquefaction (sandboils) were observed on Centerville Beach and along the Eel River. The Centerville Beach features were subtle and had been overtopped by high tide washover. Small sandboils were better preserved on the banks of the Eel River and associated with spread failures ranging in length from less than a meter to 20 meters.

Liquefaction features. Left – remains of sandboils at Centerville Beach. Right – sandboil along the Eel River.

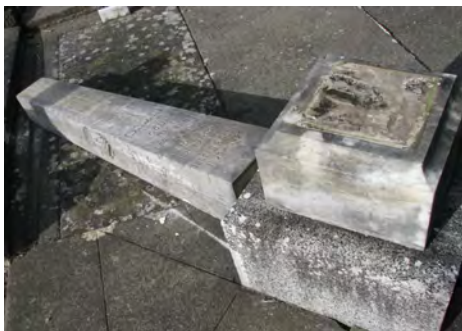
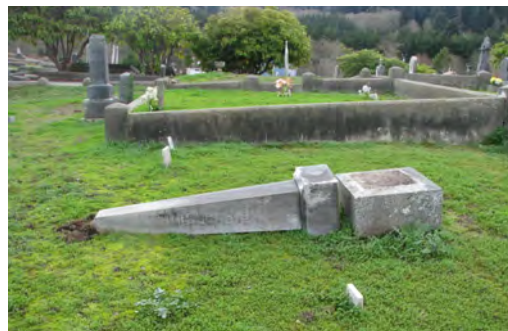
The maximum recorded shaking was observed in Eureka (33%g), which is sufficient to cause moderate damage. The instrumentally-computed shakemap shows a zone of strong shaking along the coast extending from the Eel River Valley to Eureka. About 20% of the vertical monuments at the Ferndale cemetery were toppled or displaced and preliminary analysis suggests an east-west alignment.

Toppled monuments at the Ferndale Cemetery. Both of these monuments have collapsed to the west.

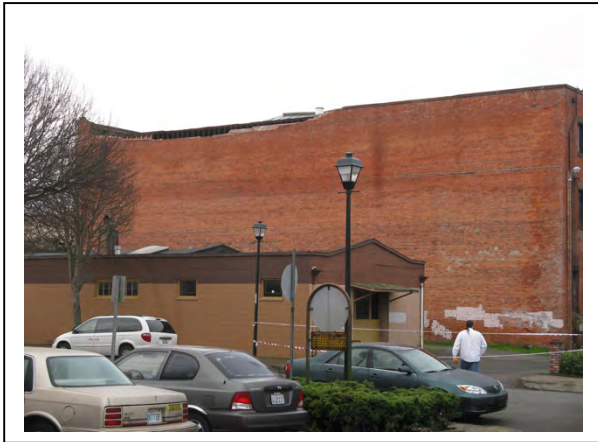
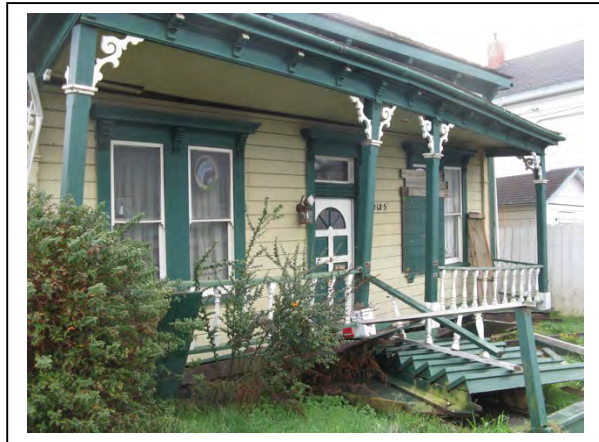
Impacts (from newspaper accounts and government assessments)
 The Humboldt County (CA) Office of Emergency Services and the Humboldt County Emergency Operations Center were activated and conducted assessments and information gathering. The CA State EOC was not activated. About 30 people visited hospitals for minor injuries, and one report of a major injury (an elderly man with a broken hip). Damage was greatest in Eureka. In Eureka there were 219 reports of damage to homes and commercial buildings (foundation damage, damaged parapets, cracked walls, toppled chimneys and driveways). Damage estimates as of January 12 exceed \$20 million in the county. The largest losses to structures (all in Eureka):

Bayshore Mall (Broadway)	\$6,000,000
US Post Office (5 th & H St.)	\$1,000,000
Lloyd Building (211 5 th St.)	\$1,000,000
Reflections Gallery (417 2 nd St.)	\$1,000,000
Eureka Marina Dock B (Marina Way)	\$750,000
Old Town Bar & Grill (325 2 nd St.)	\$700,000
Arkley Center (5 th & G St.)	\$300,000
The Pearl (507 2 nd St.)	\$200,000
Ray's Food Place (Broadway)	\$200,000
1200 W. Del Norte	\$200,000
Carson Block Building (231 F St.)	\$200,000
