# Clearinghouse Briefing

Monday, August 25, 2014

# Preliminary Team Reports

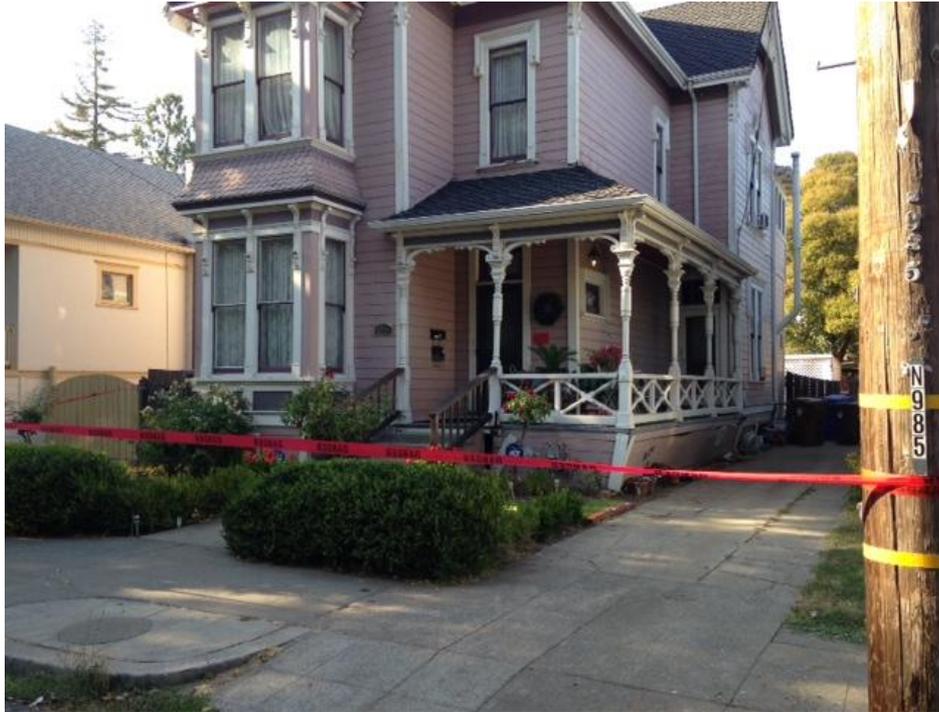
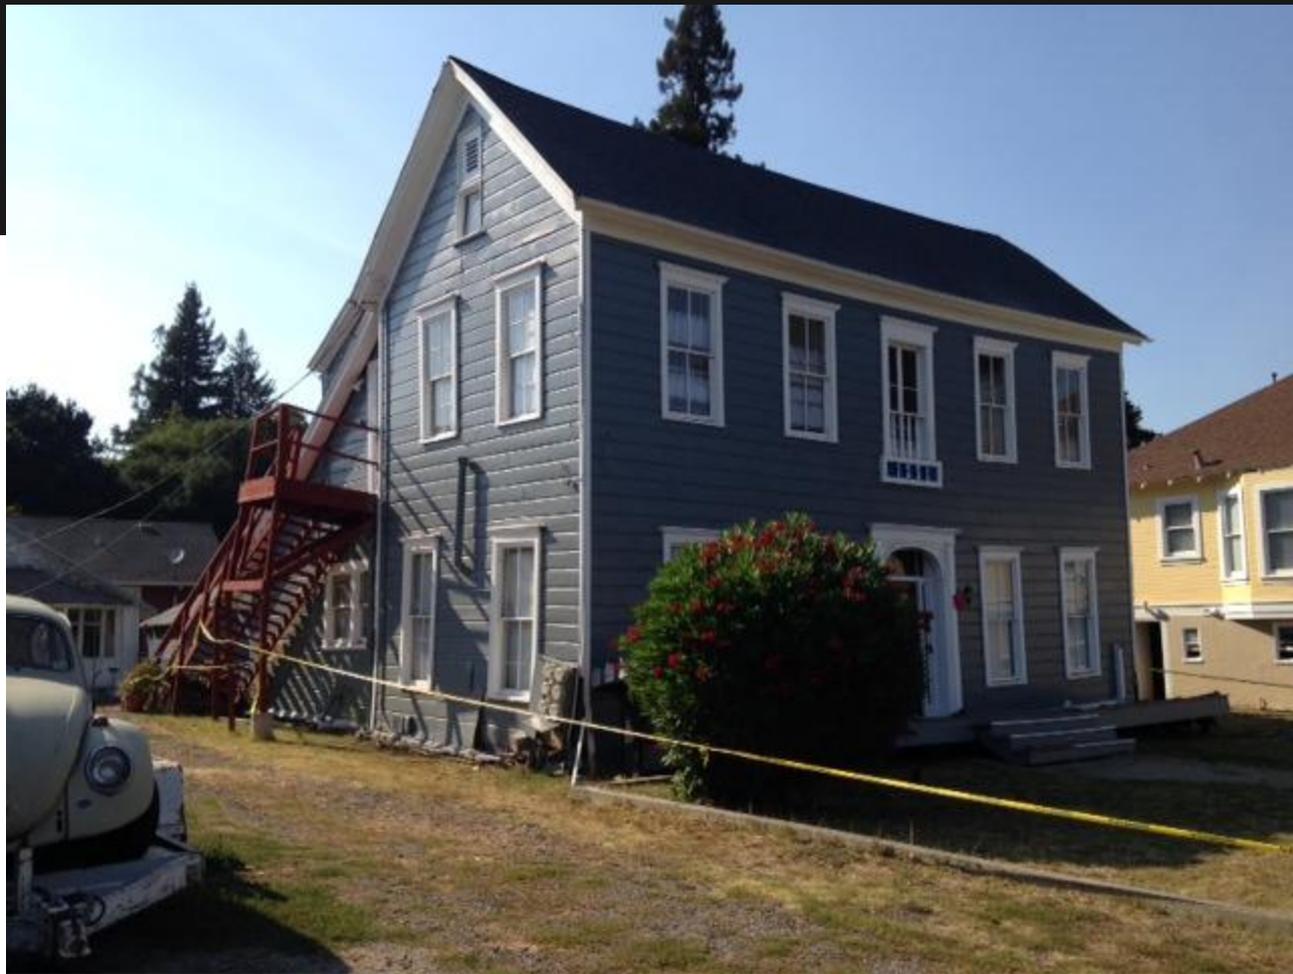
# K. Telleen & V. Crothers

- Jefferson west of downtown Napa
  - Two cripple wall failures
  - Many toppled chimneys
- West of Main Street north of downtown
  - Cripple wall distress to 30% of houses
  - A few houses shifted west on foundations
- South of downtown
  - Chimney damage

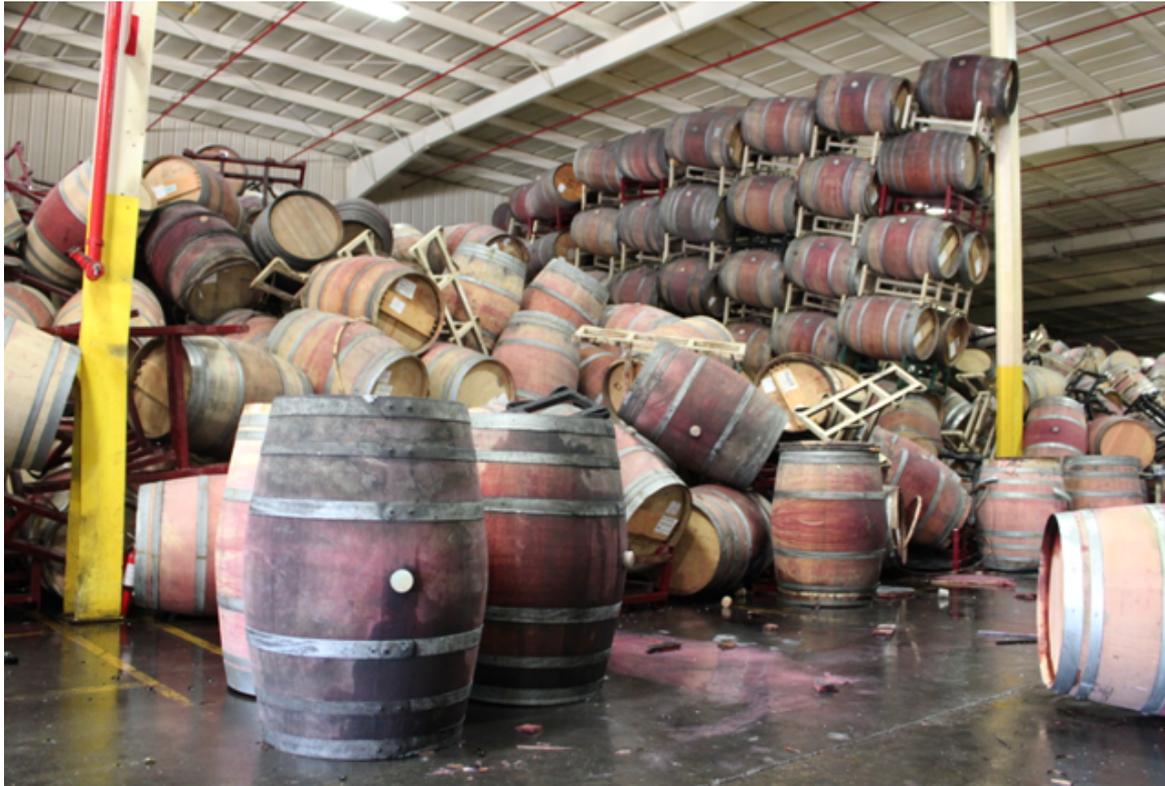
# Winery Inventory Damage

- Extensive barrel storage damage
- The recovery process is slow and dangerous
- Building owner/manager/wine owner
- Co-operative facilities particularly difficult
- Limited tank damage, mostly barrels

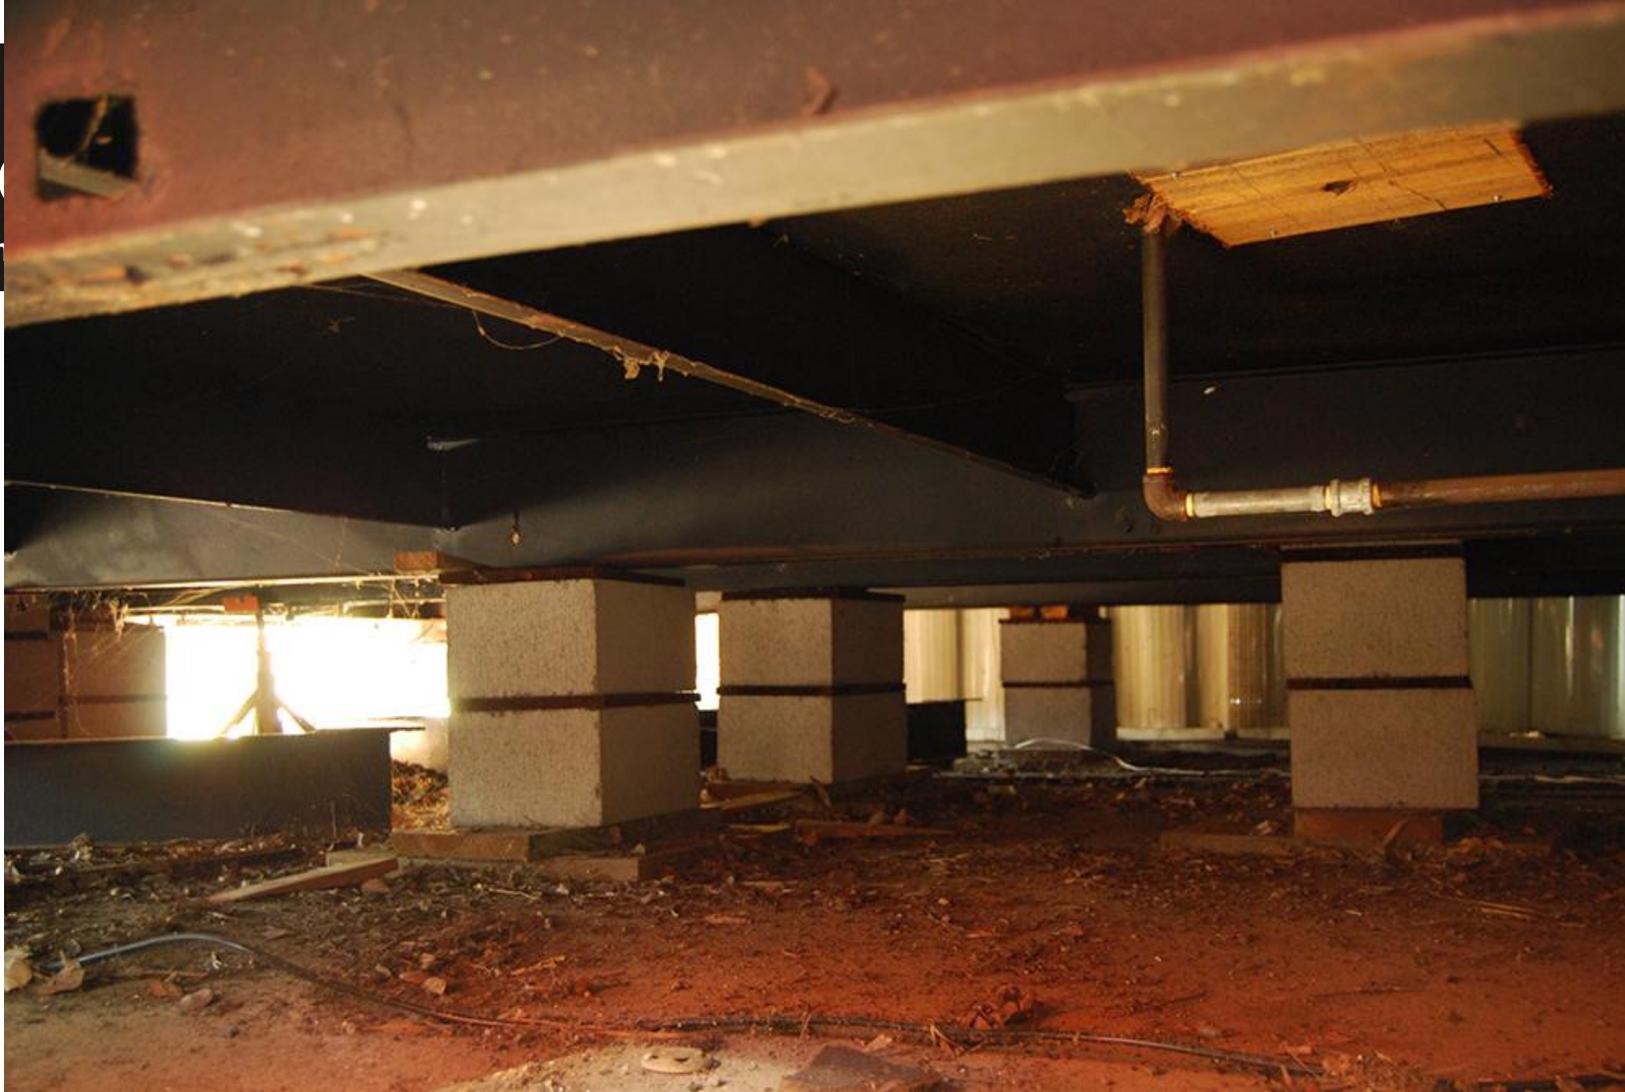
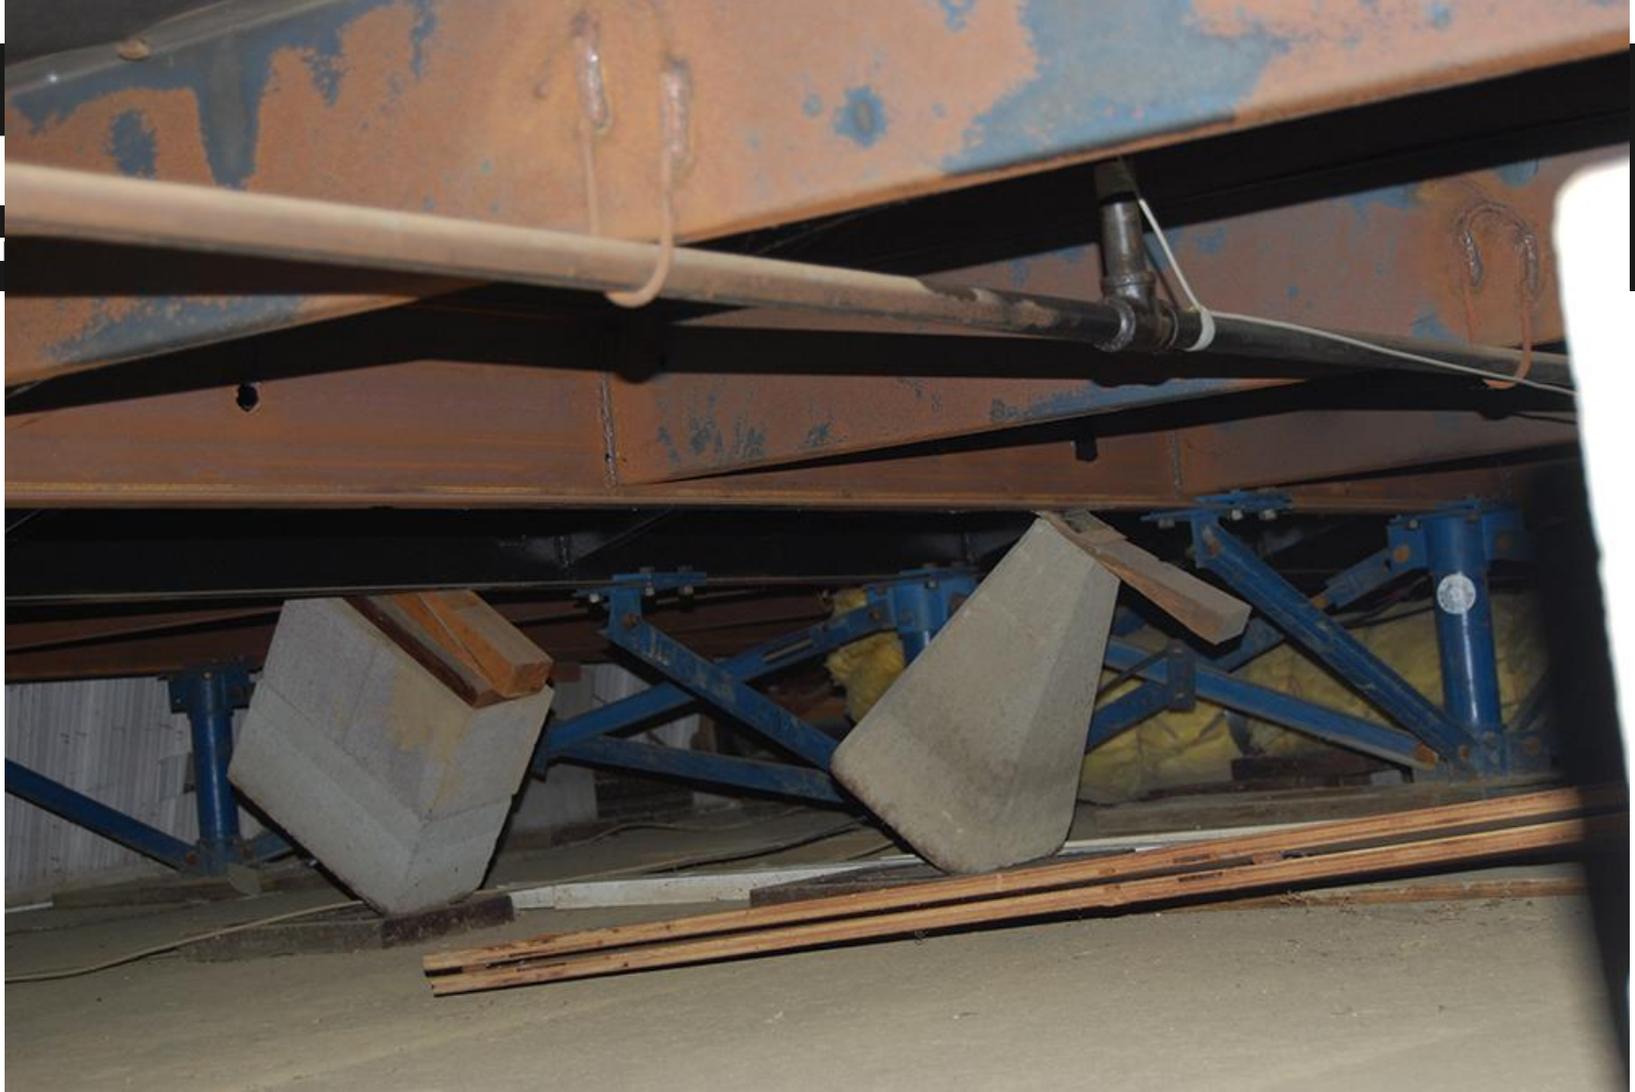
- Windshield Survey of 4 mobile home communities
  - roughly 100-150 units per community
- At Salvador Estates walked and surveyed 81 structures.
  - 22 team labeled moderate or worse damage
    - Home was significantly shifted off foundation.

- All homes were on concrete blocks (~2' of ground)
  - Most of homes shifted off foundation fell West.
  - Handful of retrofitted homes with steel bracing.
    - Anecdotal story “After 1989 decided to retrofit, cost \$8,000 then” had minimal damage in event.
-

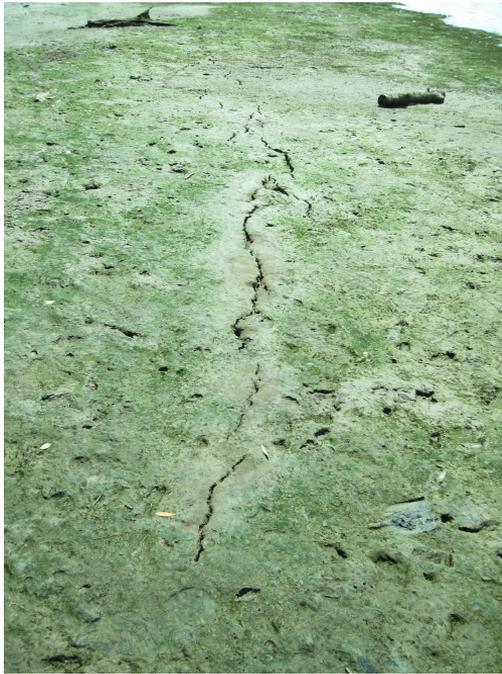
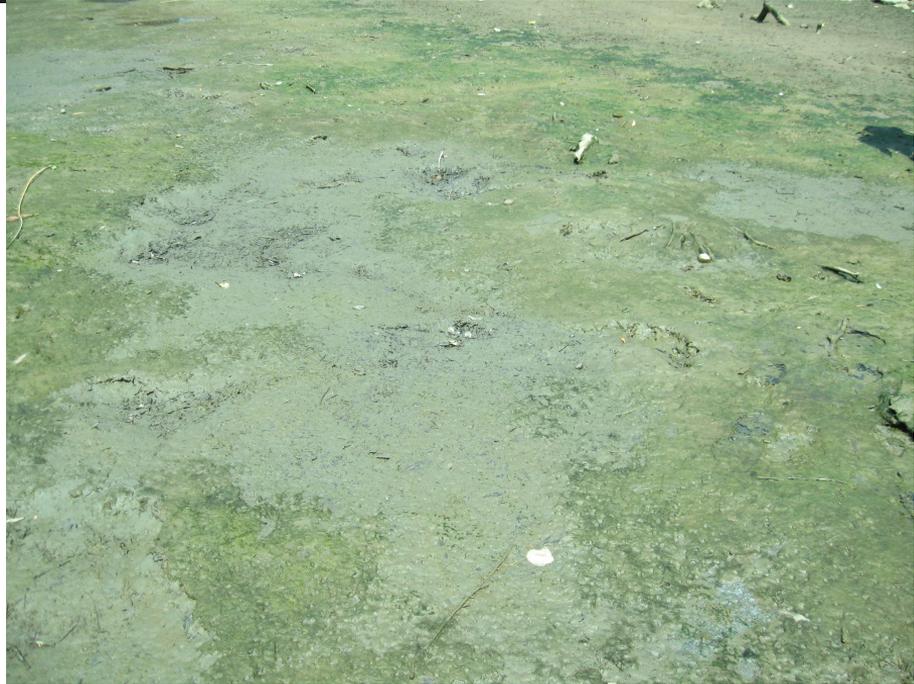
- Observed all bridges over Napa Creek and First and Third Street Bridges over Napa River
- Bridges over Napa River had deck movement on the order of 2 inches
- Third Street bridge had sand boils/fissures, lateral spreading and subsidence

Sand Boils and Fissures Near Third Street Bridge

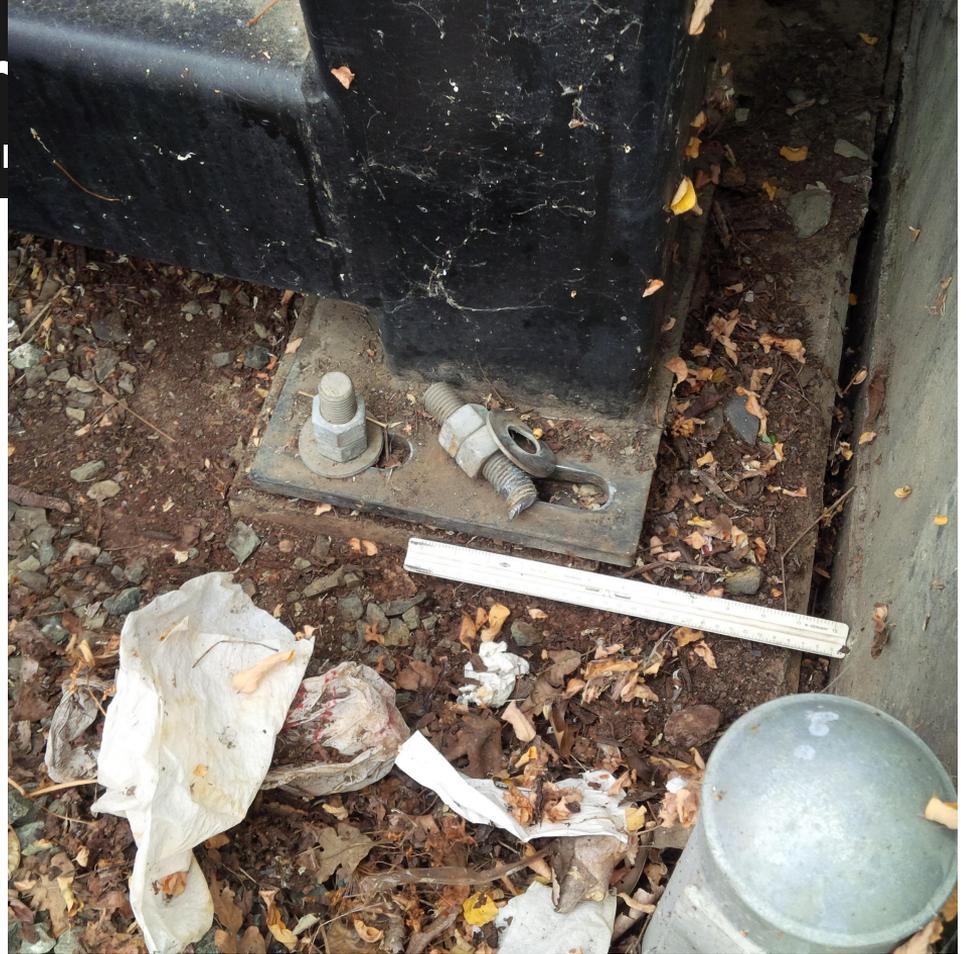
- Coombs Street Pedestrian Bridge: Retaining wall movements, backfill subsidence and lateral movement, minor cracking, sheared connector bolts on southwest corner and rest of the bolts were bent; bridge should remain cordoned off

Sheared off bolt on  
Coombs Street  
Pedestrian Bridge

- Bridges
  - Coombs St Pedestrian Bridge - structural survey
    - Surveyed by Zia Zaffir and Bill McCormick (Kleinfelder): Deck bolts sheared off on southwest corner (2 of 4), on other corners bolts are distorted. Large retaining wall apparent outward movement at top.
