EERI Special Earthquake Report

M 6.0 South Napa Earthquake of August 24, 2014

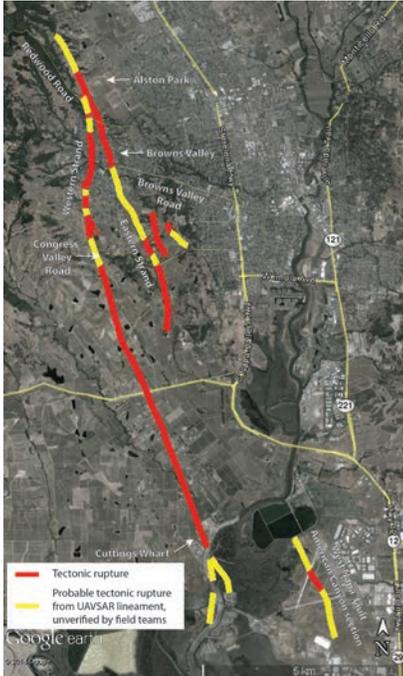
Figure 7. Map showing location of observed and inferred South Napa Earthquake fault rupture. Image base from Google Earth (source: Dawson et al., 2014).

Surface Rupture. The earthquake produced more than 14 km of surface rupture from the Napa River at Cuttings Wharf in the south, to beyond the northern boundary of Alston Park in the city of Napa, in the north (Figure 7). The surface rupture is largely west of most mapped traces of the West Napa fault zone, although it is coincident with the western-most Quaternary trace of the West Napa fault, and locally with mapped bedrock faults (Clahan et al., 2004). The fault was previously unrecognized where it was covered by younger sediment, particularly near its northern end in Browns Valley, and at its southern end near the Napa River.

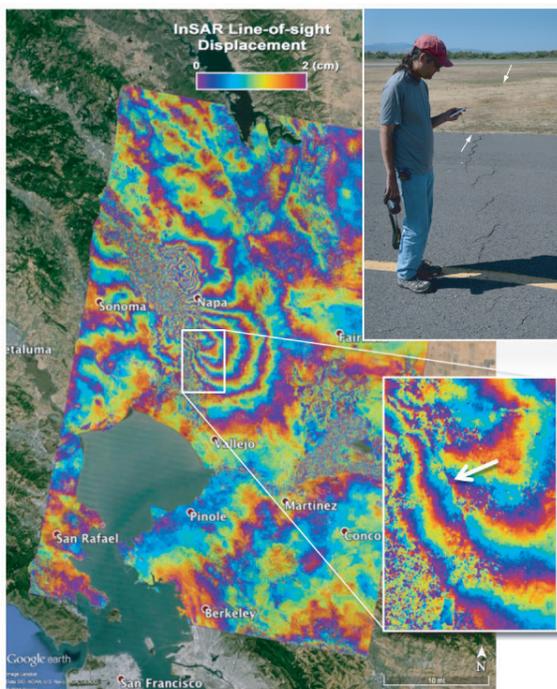
Minor right-lateral offset, likely less than a few centimeters, also was observed crossing two taxiways at the Napa County Airport (Figure 10). This rupture is located on the mapped trace of the Airport Section of the West Napa fault zone as designated by Bryant (2000), and the rupture was first identified by X-band InSAR results from NASA's Jet Propulsion Laboratory Advanced Rapid Imaging and

Analysis (ARIA) mission, using the Agenzia Spaziale Italiana's COSMO-SkyMed satellite. Rupture at the airport was verified by geologists in the field (Figure 10). Uninhabited aerial vehicle synthetic aperture radar (UAVSAR) imagery flown five days after the earthquake proved to be useful in identifying other areas of possible faulting, and was especially useful in identifying linear zones of deformation that would likely have been missed in the field without the benefit of the InSAR and UAVSAR imagery.

Figure 10. COSMO-SkyMed X-band InSAR image overlain on Google Earth Imagery showing discontinuity (white arrow) corresponding to minor faulting at the Napa County Airport. Upper right photo shows en echelon cracks on airport taxiway (source: Ken Hudnut, USGS). Arrows denote pre-earthquake vegetation lineament and low scarp (source: NASA Jet Propulsion Laboratory Advanced Rapid Imaging and Analysis (ARIA) mission http://photojournal.jpl.nasa.gov/figures/PIA18798_fig1.jpg).

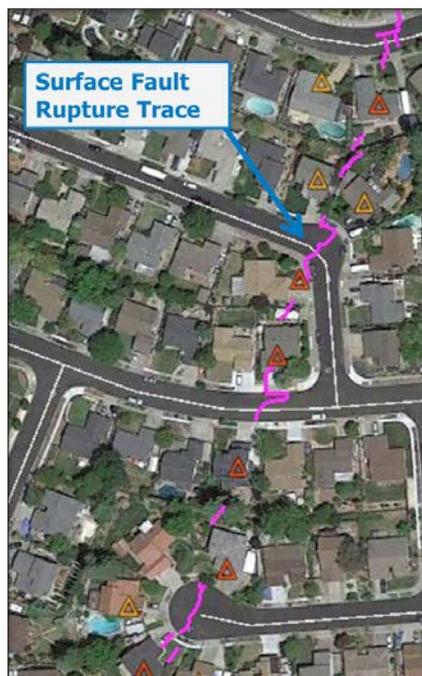
Figure 13. Surface fault rupture in Browns Valley area (fault trace mapped by NSF-GEER team members overlain on GoogleEarth™ image; source: Bray et al., 2014).

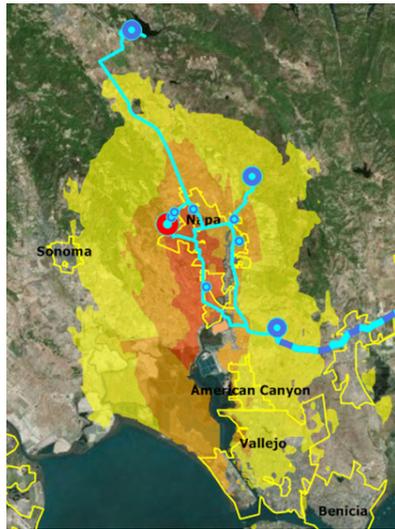
Figure 16. Schematic of City of Napa water system overlaid on MMI and showing three sources (large dark blue circles) and main transmission lines, locations of distribution tanks (smaller circles) and damaged Montana “B” tank. The California Water Project’s North Bay Aqueduct, which feeds Barwick Jamieson WTP, is shown as dashed light-dark blue (source: Charles Scawthorn, SPA Risk).

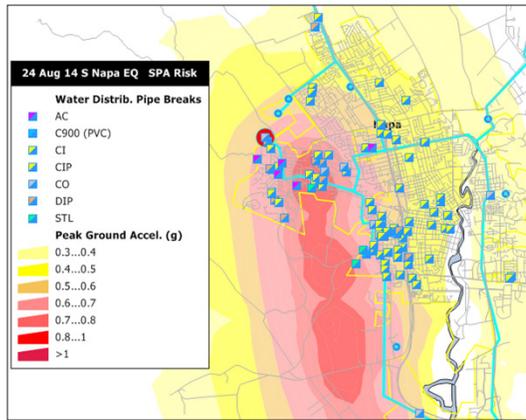
Figure 17. City of Napa water system overlaid on PGA, showing locations of breaks and Montana “B” tank (data: City of Napa; map: Charles Scawthorn, SPA Risk).

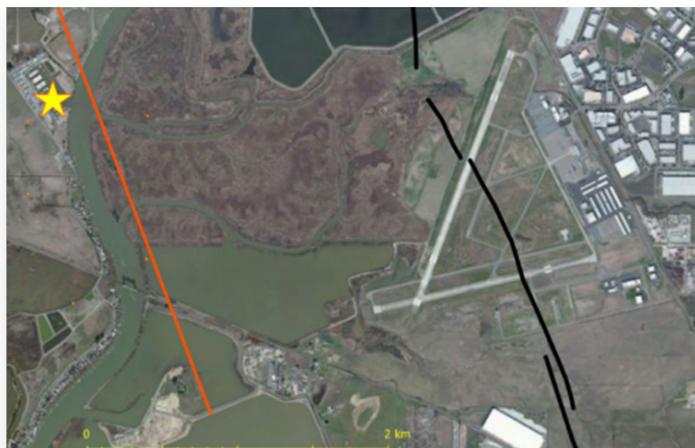
Figure 25. Napa airport with inferred fault trace in red (epicenter star), and mapped trace of W. Napa fault in black (base map: Virtual Earth; annotations: Charles Scawthorn, SPA Risk).

Air. The Napa County airport reported no damage to any of its own facilities, although minor cracking was reported on one runway (see Figure 25). Operations were suspended from normal opening time (7:00 am) for 30 minutes to allow inspection and then were resumed. The airport lost normal commercial power, but backup power functioned satisfactorily.

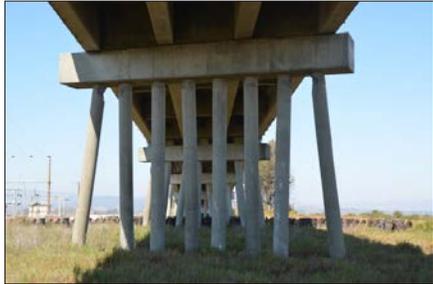
Figure 27. lower photo--Napa Slough Bridge; upper photo--typical damage to pile extensions on the Napa Slough Bridge (photos: Mark Yashinsky).

so the substructure was retrofit with large-diameter cast-in-steel shell (CISS) piles supporting the ends of the enlarged bent cap when it was widened in 1999 (Figure 26). The bridge is two miles from the local agency-owned Napa Slough Bridge (Figure 27), which had a similar substructure, similar soft soil, and a similar level of ground shaking during the earthquake. There was no damage to the Sonoma Creek Bridge while the Napa Slough Bridge had serious damage (Figure 27).

The ends of the pile extensions on the Napa Slough Bridge had deep cracks and spalls into the core region. Fortunately, the #4 hoop reinforcement at 12 inches was strong enough to hold onto the longitudinal reinforcement and prevent the failure of the piles. If the earthquake had been of longer duration, the piles may have failed.

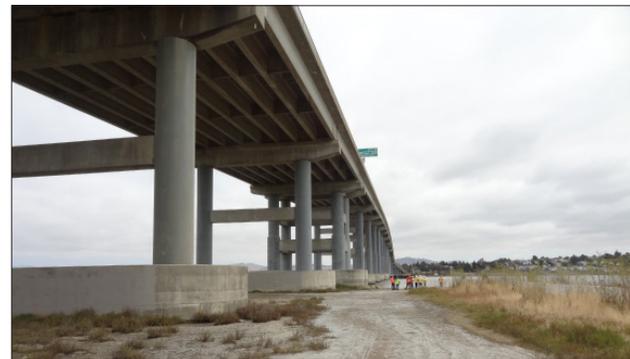
Figure 29. Retrofitted Napa River Bridge with large foundations, steel column casings, and strengthened precast girder connections (photo: Mark Yashinsky).

The Napa River (State Route 37) Bridge, a 33-span precast girder bridge on flexible two-column piers and stiff four-column piers, was built in 1963 (Figure 29). The 1989 Loma Prieta earthquake was centered 100 km away, but the bridge was damaged due to the long-period shaking on deep bay mud. The precast girders started to pull out of the diaphragms, but fortunately didn't move far enough to collapse. The bridge was retrofitted in the 1990s with larger foundations, containing more piles, steel column casings, and end diaphragms strengthened with transverse prestressing and concrete bolsters.

The ground motion during the South Napa earthquake was low, but the bridge shook enough to damage the expansion joints at its crest. However, no primary member

was damaged and the bridge was quickly returned to service after being briefly closed for inspection.

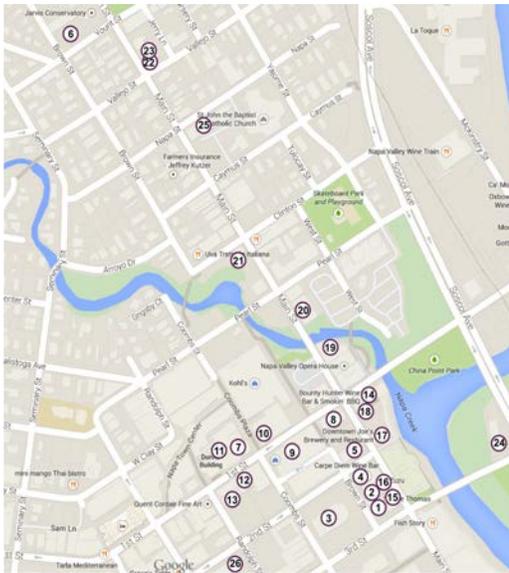
Figure 34. URM buildings observed by EERI team members/contributors (source: Andre Barbosa).

Figure 34 shows the location of URM buildings inspected by the team in the three to four days following the earthquake. Buildings in other portions of the city were not visually inspected.

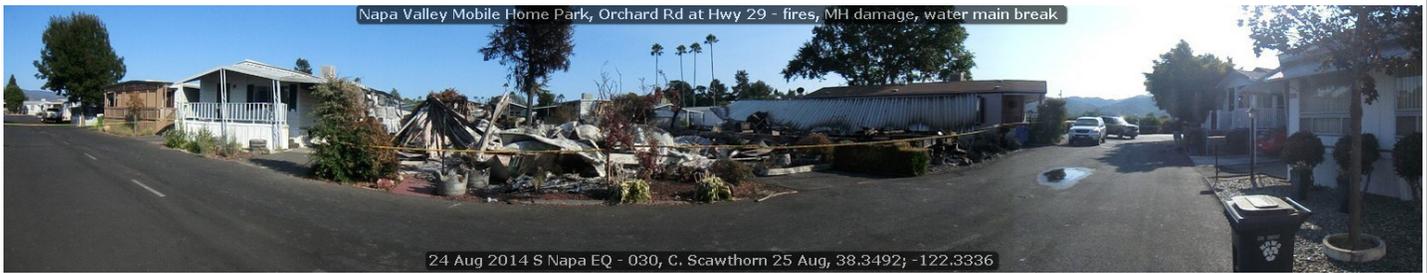
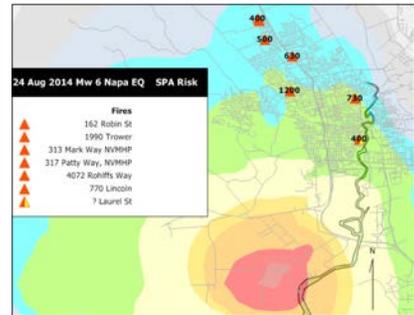
Figure 51. Fires and approximate times overlaid on PGA (half shaded triangle indicates street number unknown) (source: Charles Scawthorn, SPA Risk).

Fire sites were surveyed on the day following the earthquake (August 25), and senior officers of the Napa Fire Department (NFD) were interviewed. A complete list of incidents to which the NFD responded was not available at the time of the interview, but fires attributable to the main shock are summarized in Table 5 and shown in Figure 51 and Figure 52.

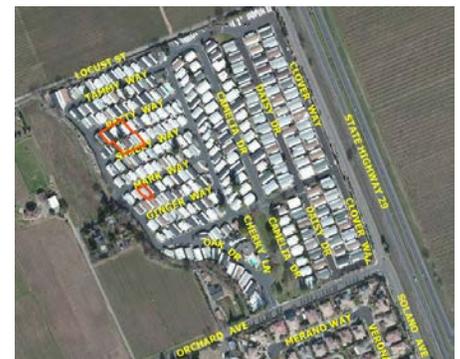
Figure 52. lower photo--locations of fires in NVMHP (damaged buildings outlined in red); upper photo--panoramic image of damaged mobile homes (photo: Virtual Earth; annotations: Charles Scawthorn, SPA Risk).

at Orchard Road, and diverted to this incident. T1 encountered a broken water main spewing water at the entrance to the park and proceeded to enter. T1 then encountered a single structure fire at 313 Mark Way, with the structure 50% involved; simultaneously, T1 observed a second fire at 317 Patty Way, which was 100% involved and impinging on neighboring buildings, see Figure 52 top). Wind conditions were calm.

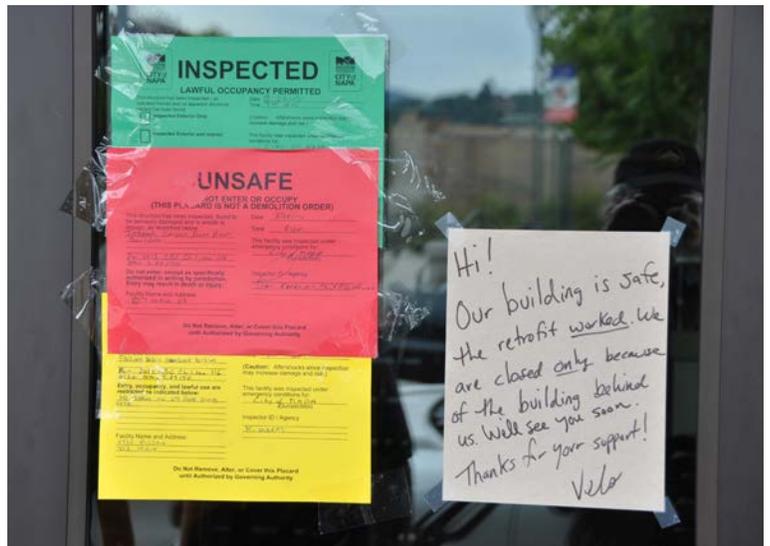
Figure 54. A red-tagged building closed due to hazards posed by an adjacent building (photo: Fred Turner).

Some undamaged buildings were also yellow or red tagged because adjacent buildings posed a life-safety hazard either from falling masonry bricks or significant façade damage (Figure 54). It may be appropriate to introduce a new tag color for this scenario to help avoid confusion for evaluators and for owners. The status of many of these businesses is currently in
